**Instituut Mijnbouwschade
Groningen**

Betreft: Uw Woo-verzoek

Date 16/12/2020
 Internal reference TUD_MemoSubsidenceModelling_ConceptV1
 Authors Jan G. Rots, Paul Korswagen Eguren, Michele Longo
 E-mail J.G.Rots@tudelft.nl, P.A.KorswagenEguren@tudelft.nl
 Document name Computational modelling checks of masonry building
 damage due to deep subsidence
 Document type Memorandum

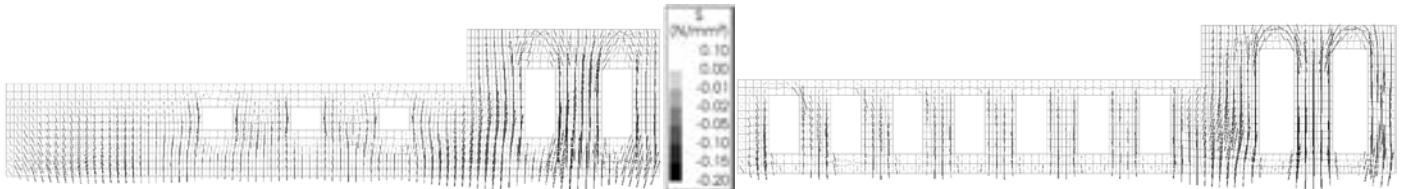
Figure 30. Principal stress compressive tensors façades subjected to hogging. Façade A (left) and Façade B (right). No deformed mesh.

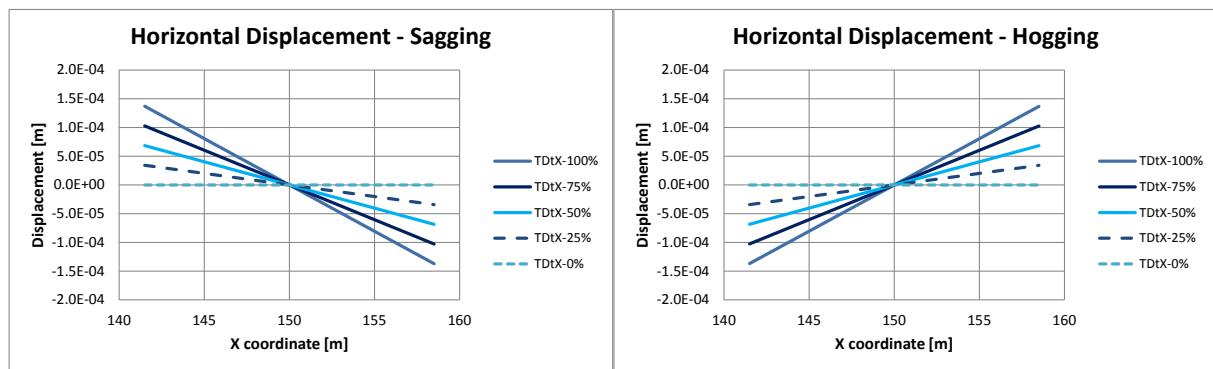
Figure 31. Horizontal displacement sensitivity for the masonry façades. Displacement applied at the foundation.

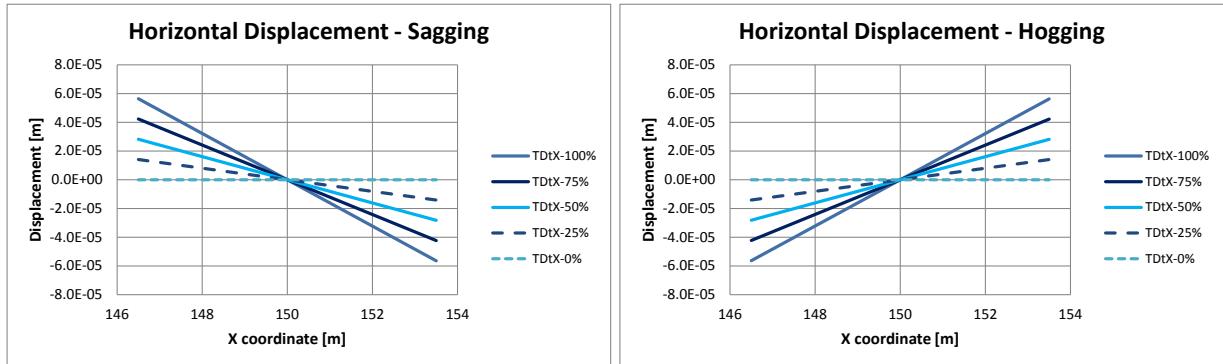
Figure 42. Horizontal displacement sensitivity for masonry façade C. Displacement applied at the foundation.

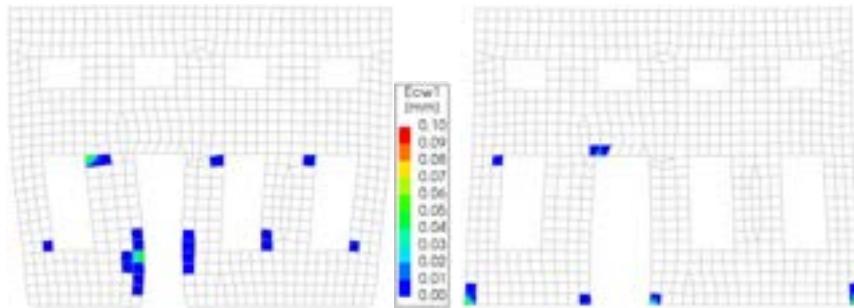
Figure 43. Principal crack width façade C. Maximum horizontal displacement applied equal to 100% of the original amplified 12.5 times (about 0.71 mm) for sagging (left), and 7.0 times (about 0.39 mm) for hogging (right). Deformed mesh magnified x500.

mainly localized at the pier at the left side of the door. For hogging settlement, cracks due to delamination at the two base corners of the façade and in the lintel above the door are present.

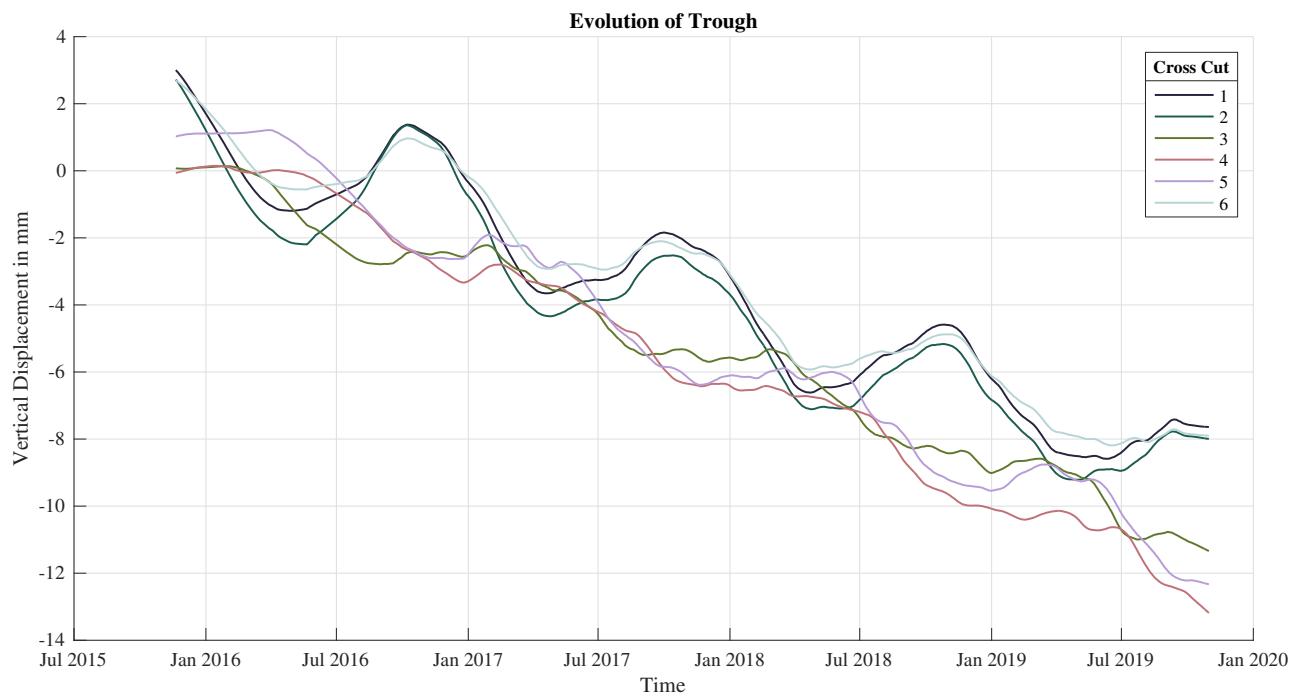
Figure 7. Trough extrema elevation over the surveyed period. A continuous subsiding trend, mixed with a seasonal variation, can be observed. This continuous, linear trend appears globally in the region and thus does not affect the local curvatures and strains.

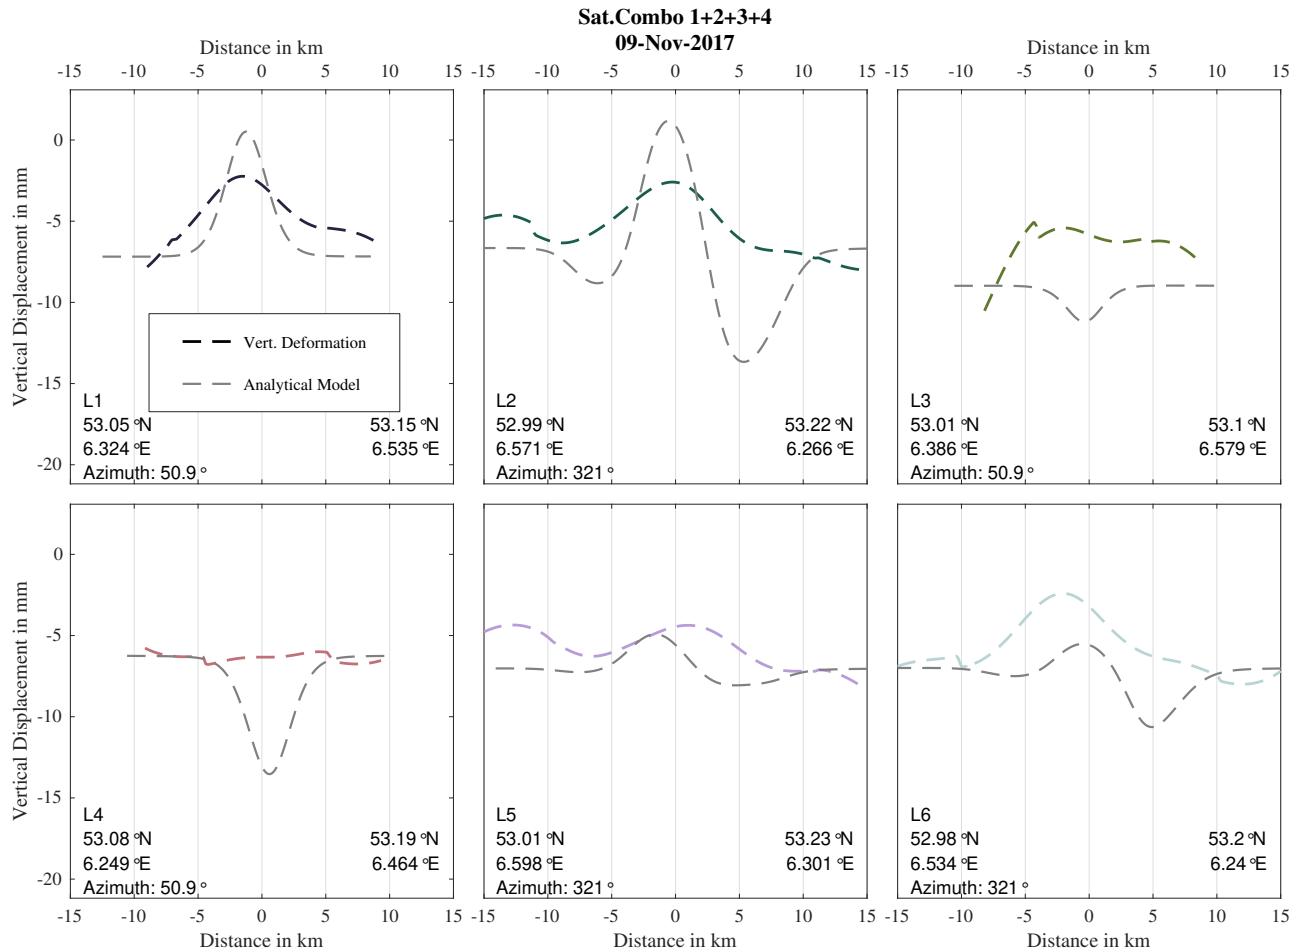
Figure 8a. Displacements over the six cross-sections for November of 2017, at the beginning of the winter season thus corresponding to maximum heave for that year. Comparison against the vertical displacement from the analytical model from TNO [4] for the full gas reservoir.

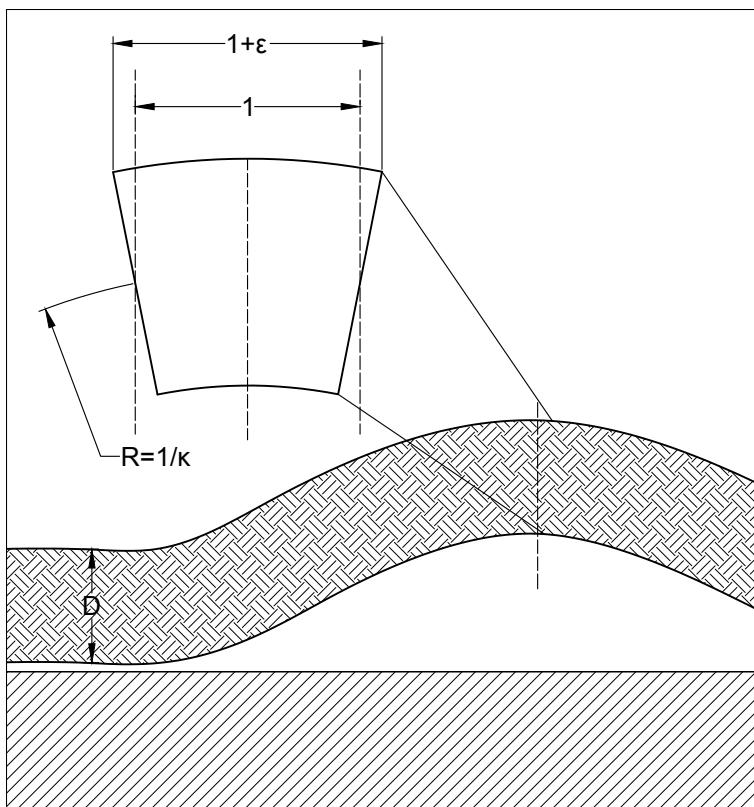
Figure A.1. Sketch of the soil layer of thickness D deformed due to gas storage and the relationship between curvature and horizontal strain. Note that deformations are greatly exaggerated for illustration purposes.

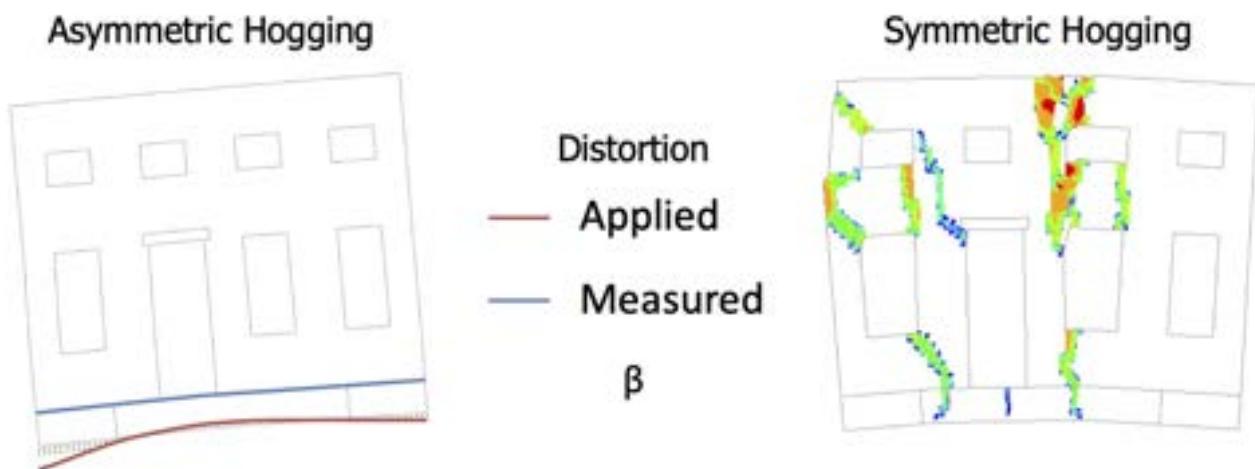
Figuur 1. Illustratie van de twee onderzochte zettingsprofielen. Links, asymmetrische hoging met differentiële zetting aan de linkerkant, het verschil tussen het aangebrachte profiel onder de fundering en het gemeten vervormingsprofiel op het gebouw. Rechts, een voorbeeld van symmetrische hoging met de locatie van de resulterende scheuren in de gemetselde gevel.

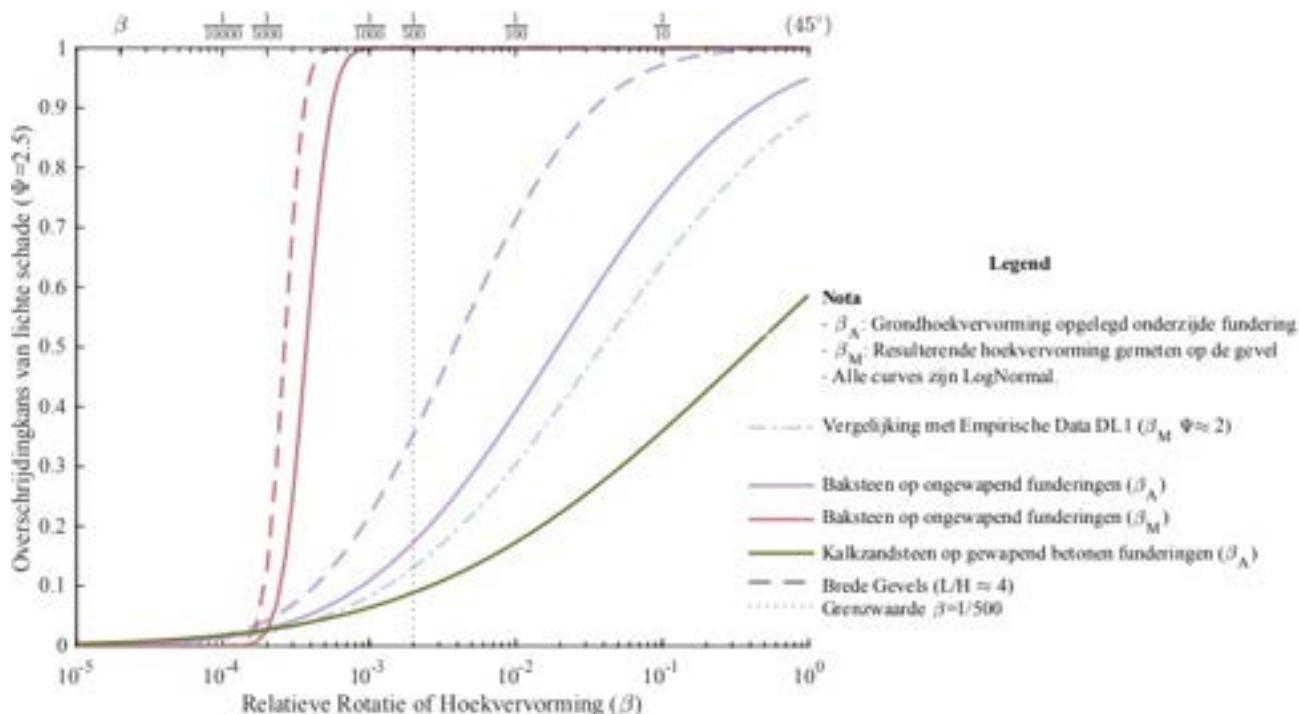
Figuur 2. Vervorming tegen de kans op overschrijding lichte schade, zowel voor de door de bodem aangebrachte vervorming als de vervorming gemeten op de gemetselde gevels. Ongeveer 70% van de gebouwen op funderingen van gewapend beton (RC) vertoonden helemaal geen lichte schade, terwijl de gebouwen op ongewapende (UR) funderingen aanzienlijk meer schade vertoonden. Lange gevels zijn gevoeliger.

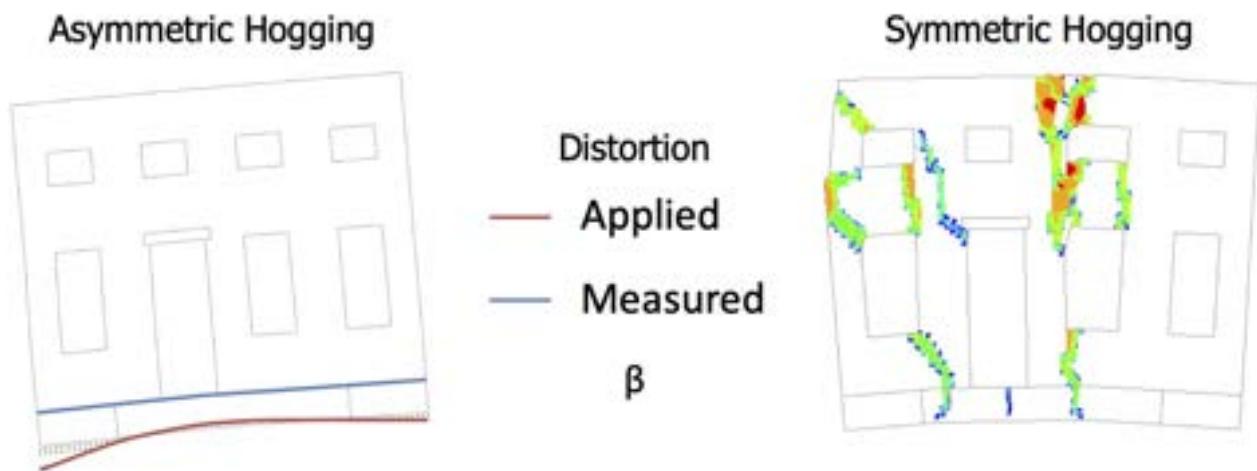
Figure 1. Illustration of the two settlement profiles investigated. On the left, asymmetric hogging with differential settlement on the left, showing the difference between the applied profile underneath the foundation and the measured distortion profile on the building. On the right, an example of symmetric hogging displaying the location of the resulting cracks on the masonry façade.

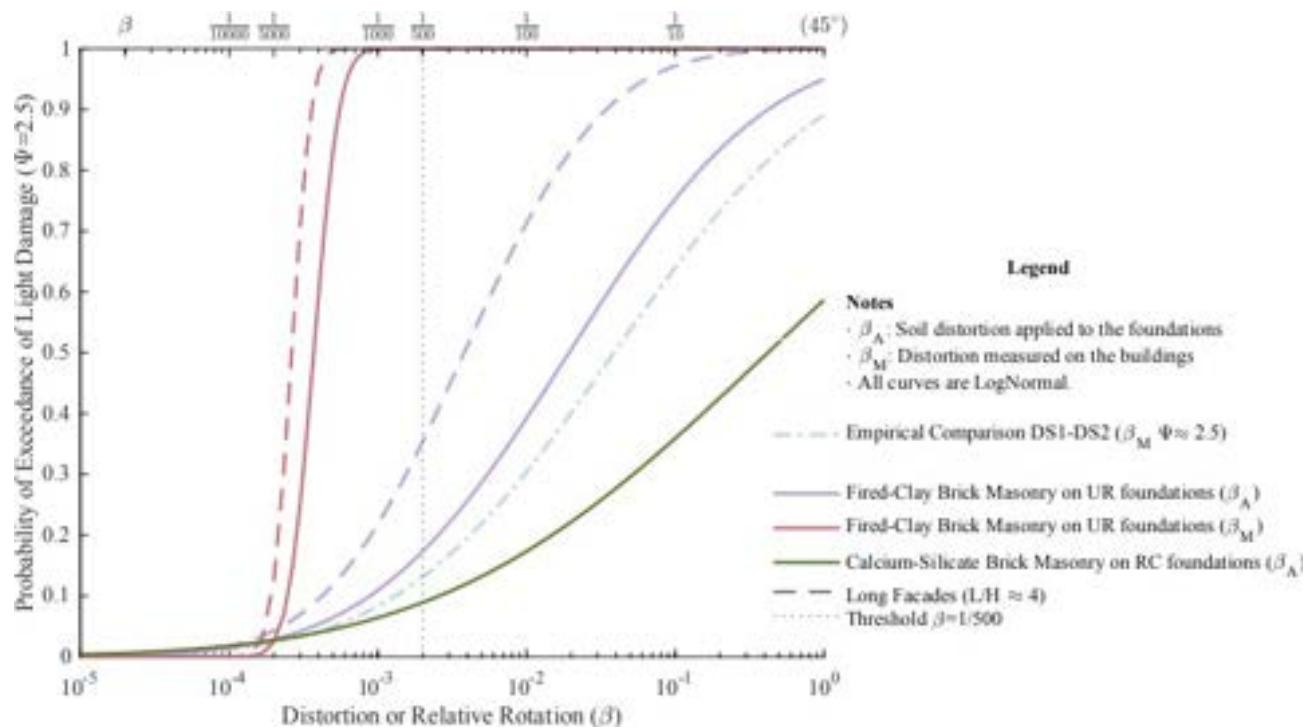
Figure 2. Distortion against the probability of exceeding light damage, both for the distortion applied by the soil and the distortion measured on the masonry façades. About 70% of the buildings on reinforced concrete (RC) foundations did not exceed light damage at all, while the buildings on unreinforced (UR) foundations displayed significantly more damage. Long façades were more susceptible to damage.

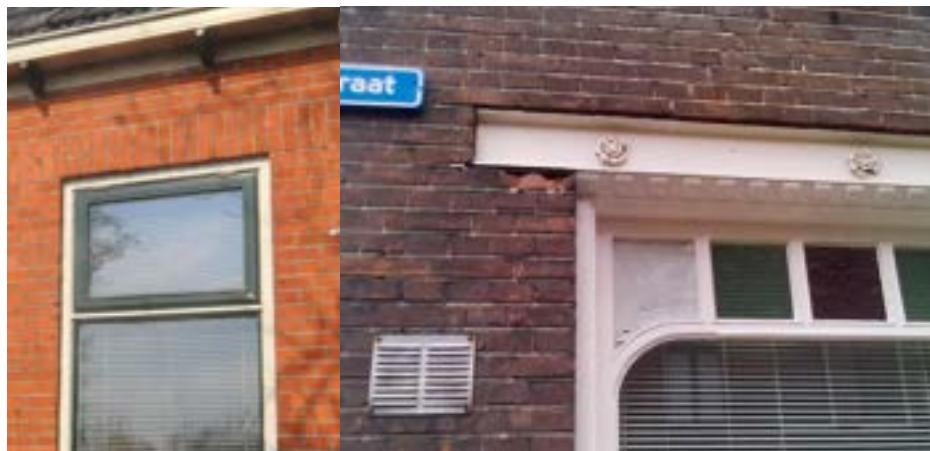
Figure 2.1. Type of lintels. Masonry lintel (left) and steel lintel (right).

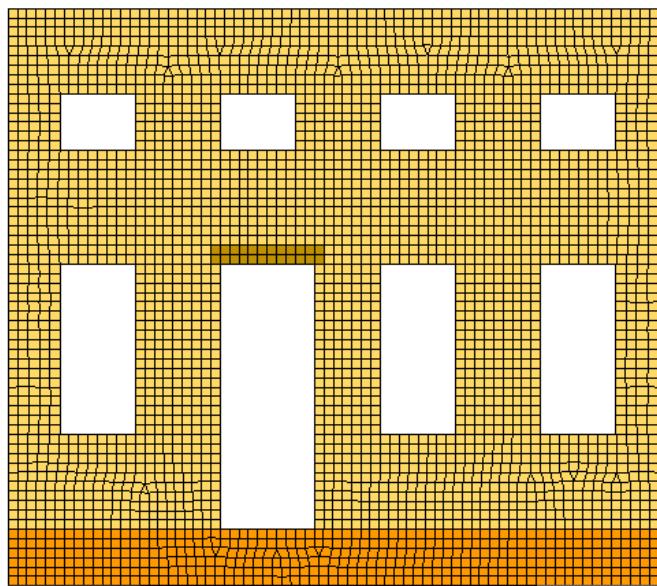
Figure 2.2. Example of FEM mesh of a masonry façade.

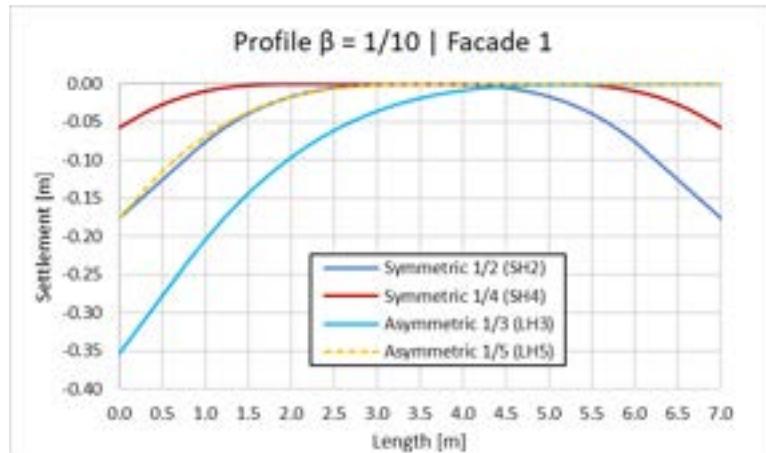
Figure 2.12. Different settlement profiles applied to Façade 1. All profiles have an angular distortion β of $1/10$.

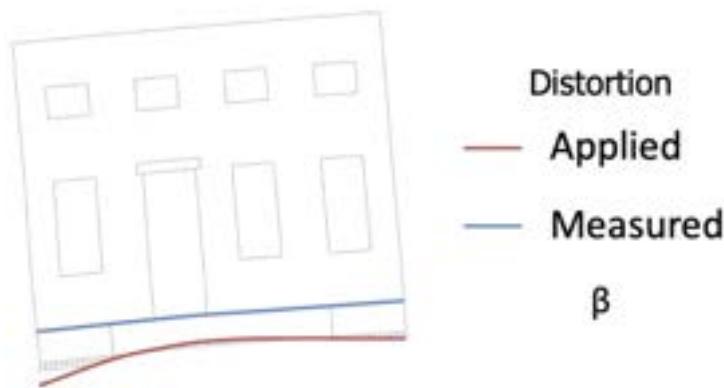
Figure 3.2. Applied and measured angular distortion β .

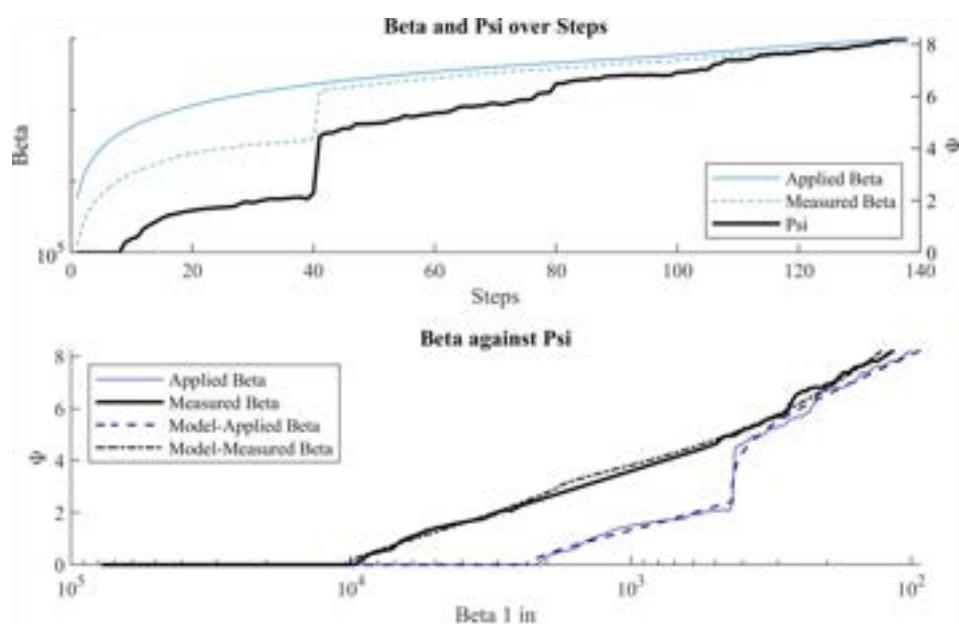
Figure 3.3. Post-processing of FEM analysis results. Angular distortion and damage over step (above) and angular distortion against damage (bottom). Facade 1-A, soil A, ‘Original Interface’, SH2, weak material.

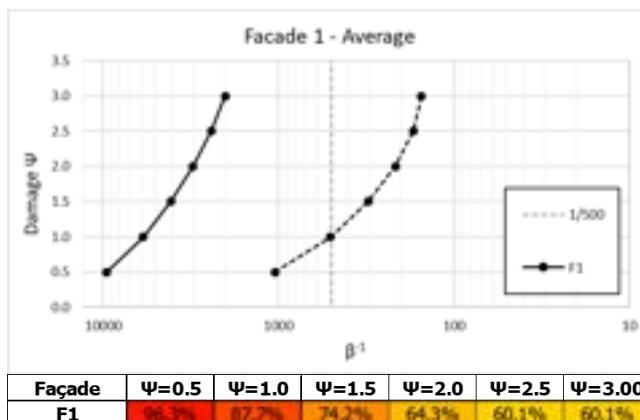
Figure 3.4. Angular distortion (β^{-1}) against damage and percentage of models that reach a specific damage level of Façade 1. Average results. Dashed lines refers to applied β .

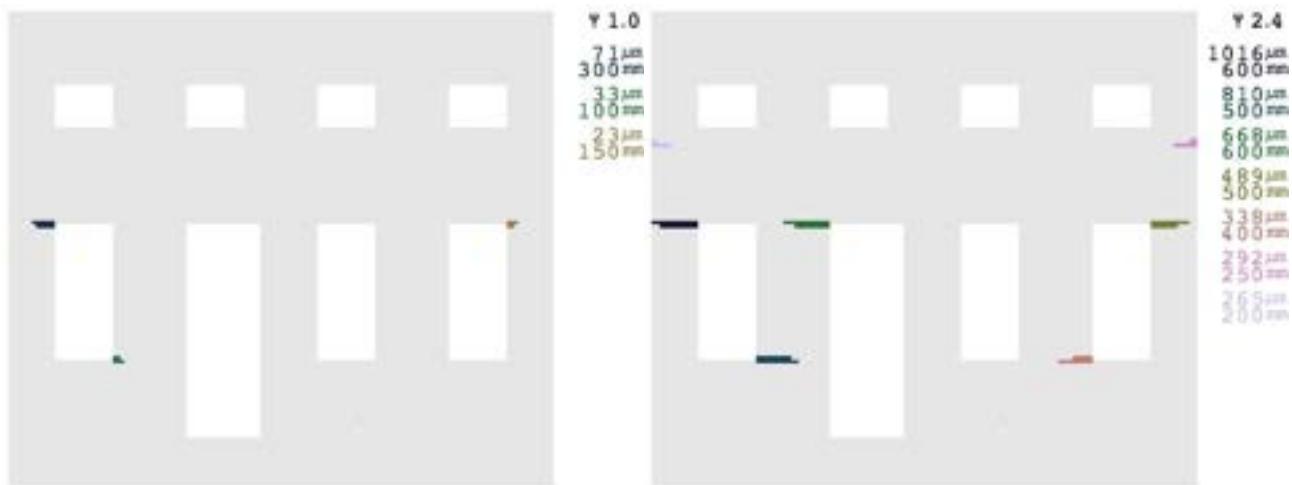
Figure 3.5. Crack pattern of Façade 1, geometry A, standard material, soil A, original interface and asymmetric settlement, knick point=L/3. Cracks at DS1 (left) and DS2 (right).

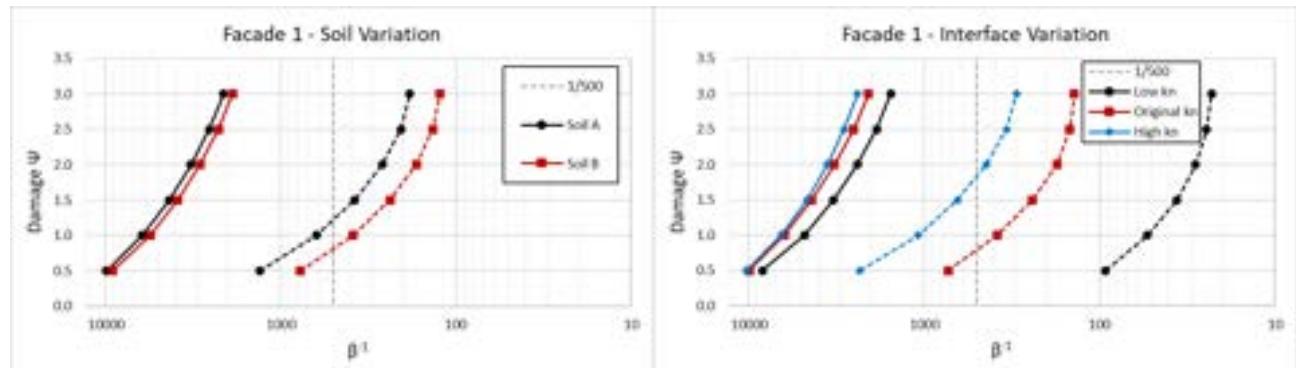
Figure 3.6. Angular distortion (β^{-1}) against damage and percentage of models that reach a specific damage level of Façade 1. Soil and interface variation. Dashed lines refers to applied β^{-1} .

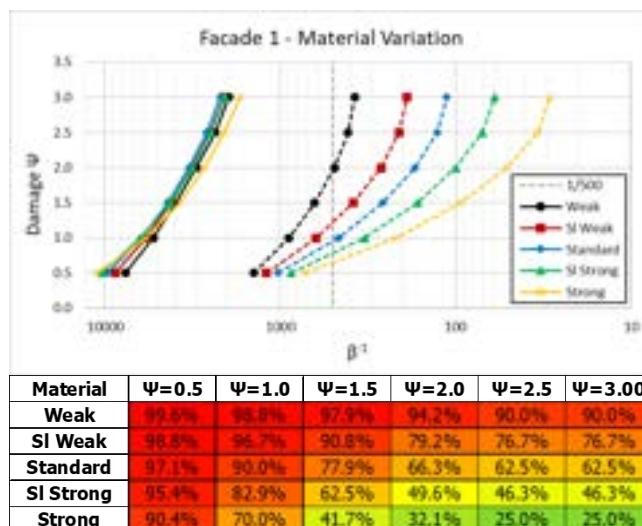
Figure 3.7. Angular distortion (β^{-1}) against damage and percentage of models that reach a specific damage level of Façade 1. Material variation. Dashed lines refers to applied β^{-1} .

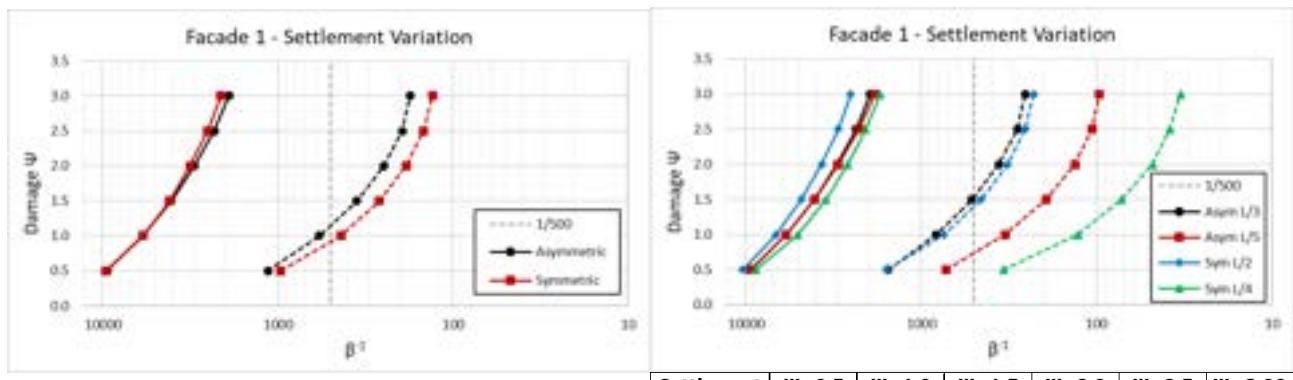
Figure 3.8. Angular distortion (β^{-1}) against damage and percentage of models that reach a specific damage level of Façade 1. Settlement variation. Dashed lines refers to applied β^{-1} .

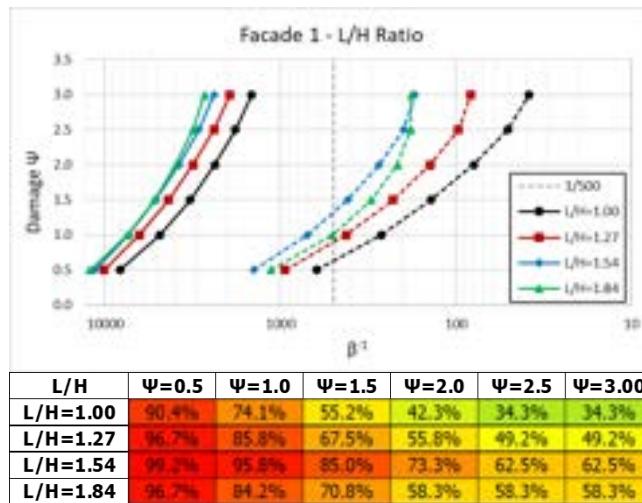
Figure 3.9. Angular distortion (${}^{\wedge}1$) against damage and percentage of models that reach a specific damage level of Façade 1. L/H ratio variations. Dashed lines refers to applied β^{-1} .

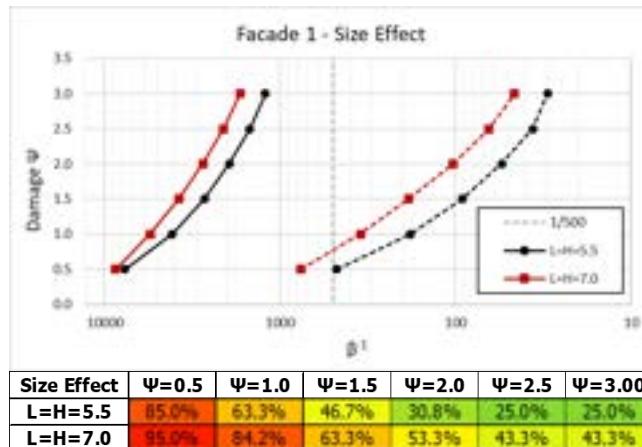
Figure 3.10. Angular distortion (${}^{\wedge}1$) against damage and percentage of models that reach a specific damage level of Façade 1. Size effect variations. Dashed lines refers to applied β^{-1} .

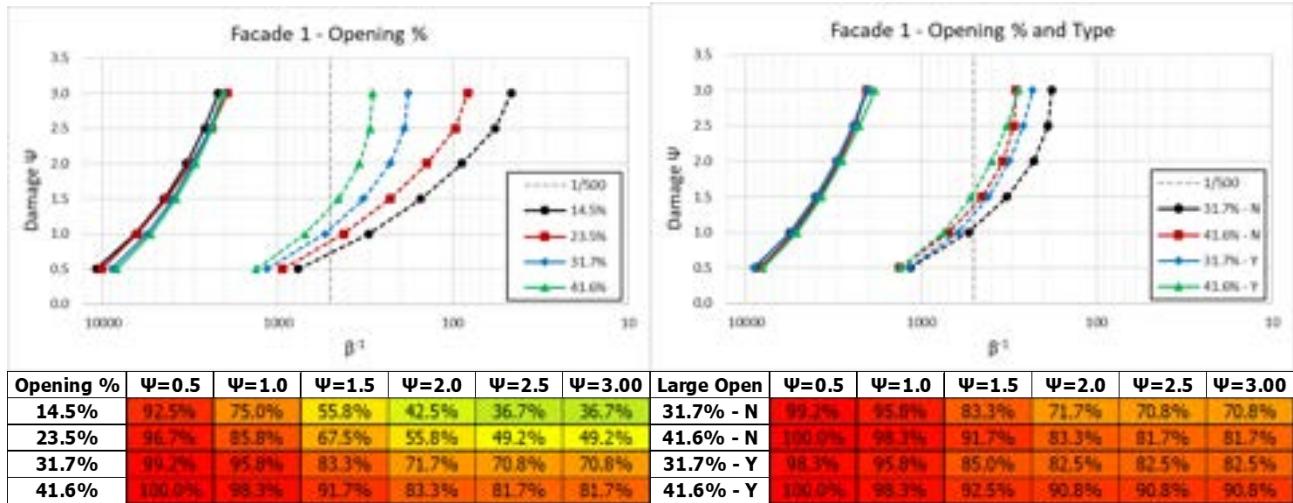
Figure 3.11. Angular distortion (β^{-1}) against damage and percentage of models that reach a specific damage level of Façade 1. Opening % and type variations. Dashed lines refers to applied β^{-1} .

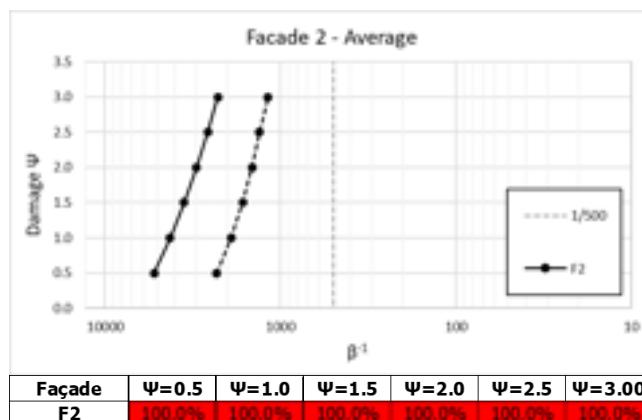
Figure 3.12. Angular distortion (\wedge^{-1}) against damage and percentage of models that reach a specific damage level of Façade 2. Average values. Dashed lines refers to applied β^{-1} .

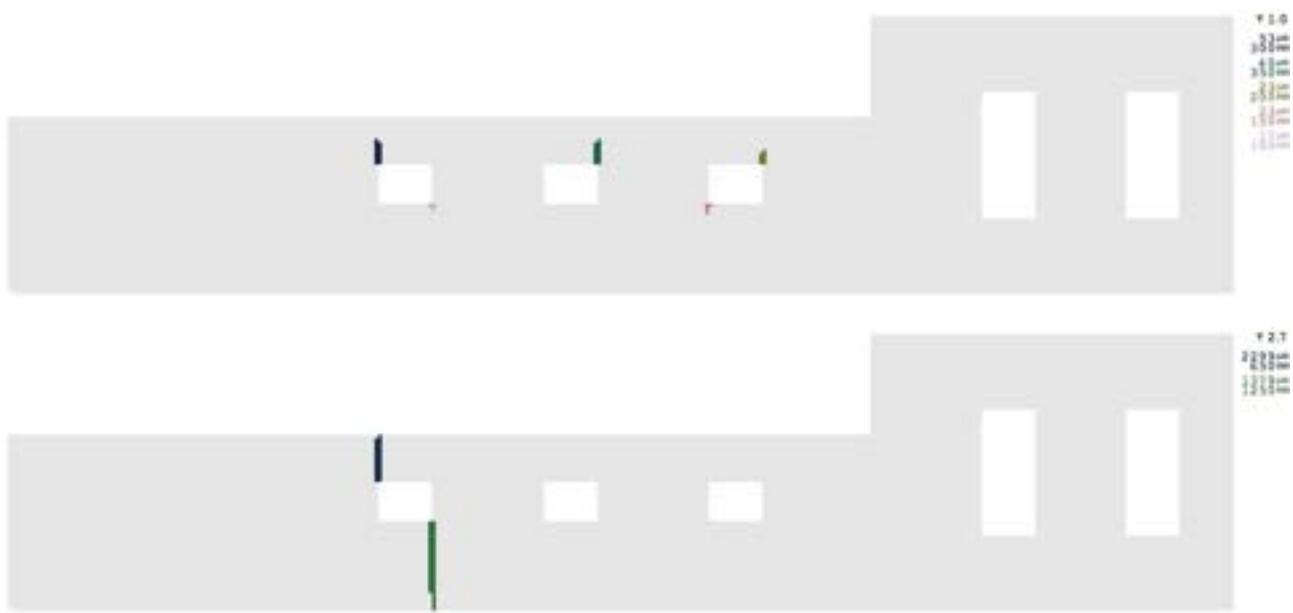
Figure 3.13 Crack pattern of Façade 2, geometry A, standard material, soil A, original interface and asymmetric settlement, knick point= $L/3$. Cracks at DS1 (top) and DS2 (bottom).

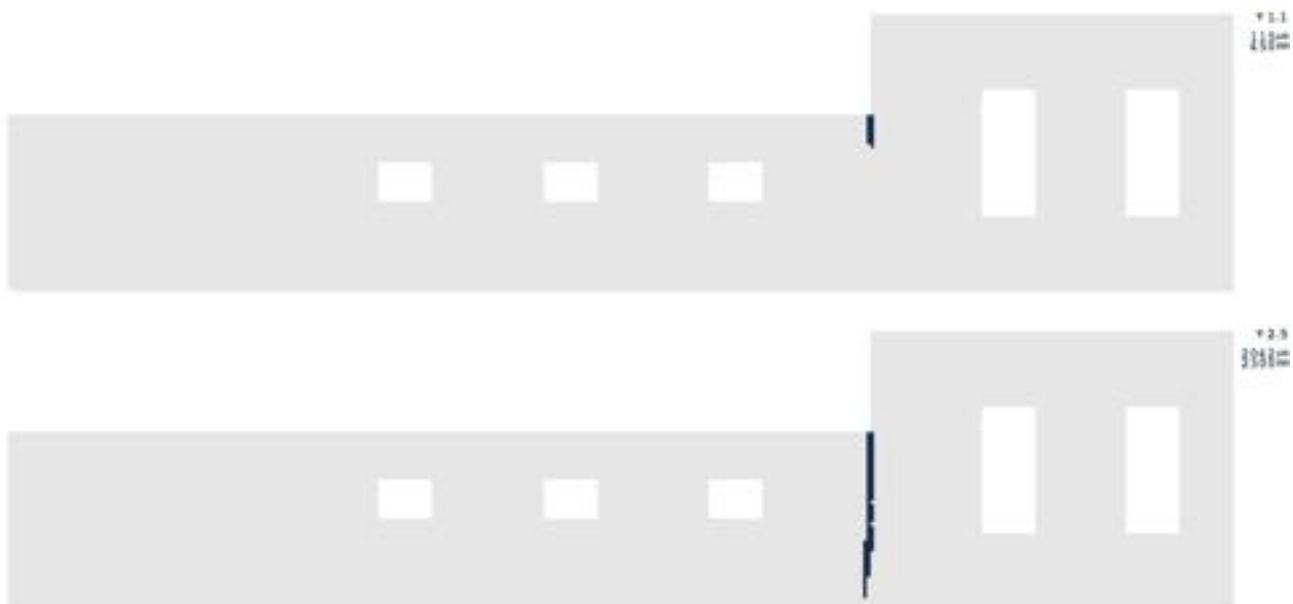
Figure 3.14. Crack pattern of Façade 2, geometry A, standard material, soil A, original interface and symmetric settlement, knick point= $L/2$. Cracks at DS1 (top) and DS2 (bottom).

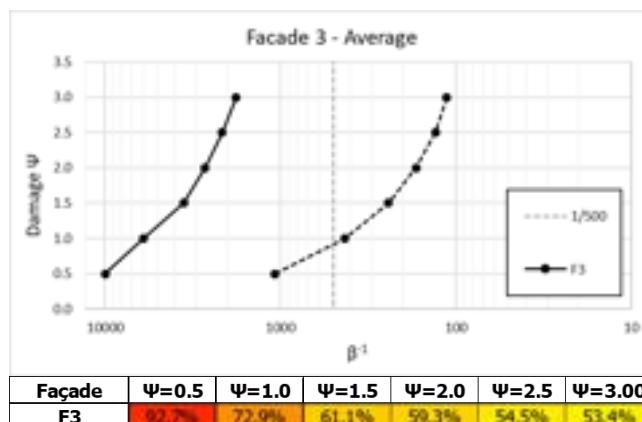
Figure 3.15. Angular distortion (β^{-1}) against damage and percentage of models that reach a specific damage level of Façade 3. Average values. Dashed lines refers to applied β^{-1} .

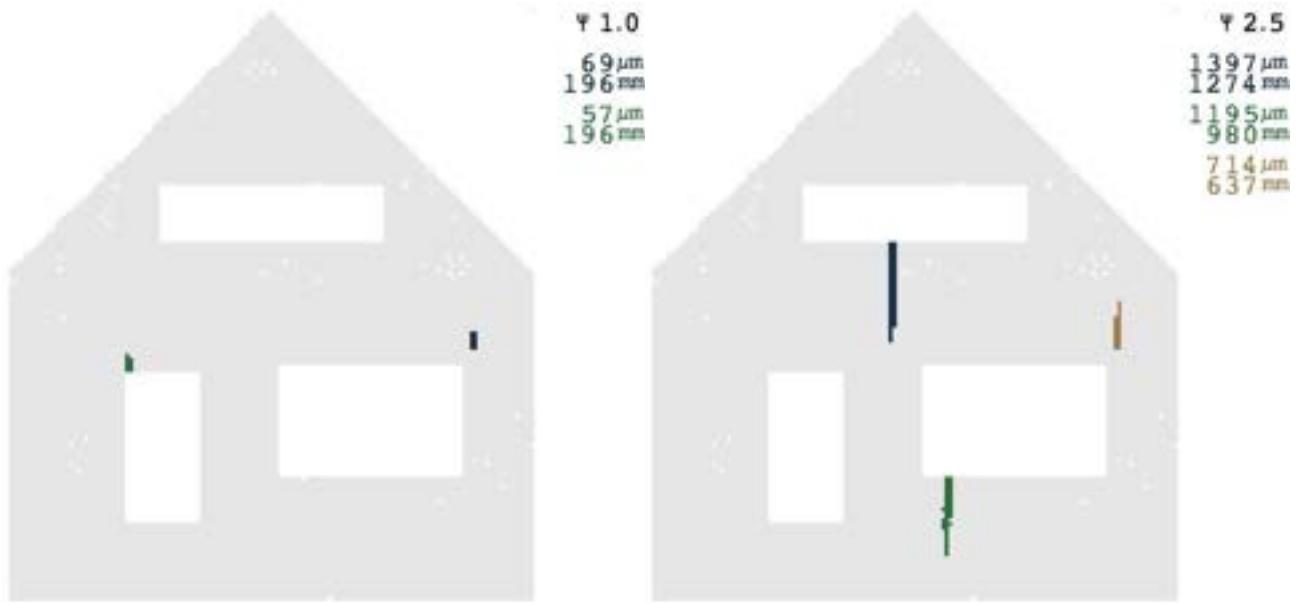
Figure 3.16. Crack pattern of Façade 4, geometry A, standard material, soil A, original interface and asymmetric settlement, knick point=L/3. Cracks at DS1 (left) and DS2 (right). Notice how new cracks allow other cracks to close.

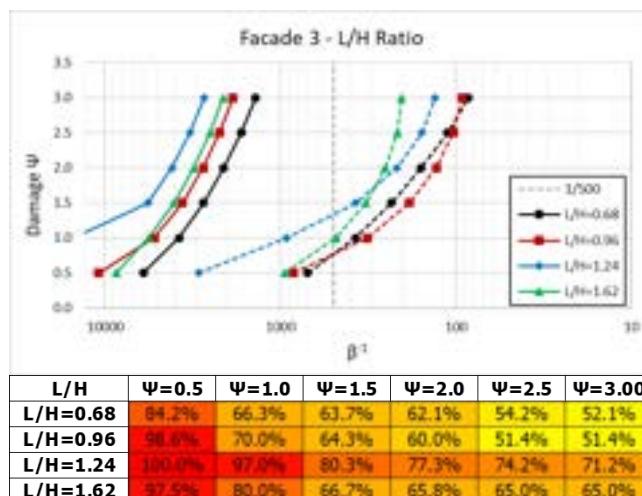
Figure 3.17. Angular distortion (β^{-1}) against damage and percentage of models that reach a specific damage level of Façade 3. L/H ratio variations. Dashed lines refers to applied β^{-1} .

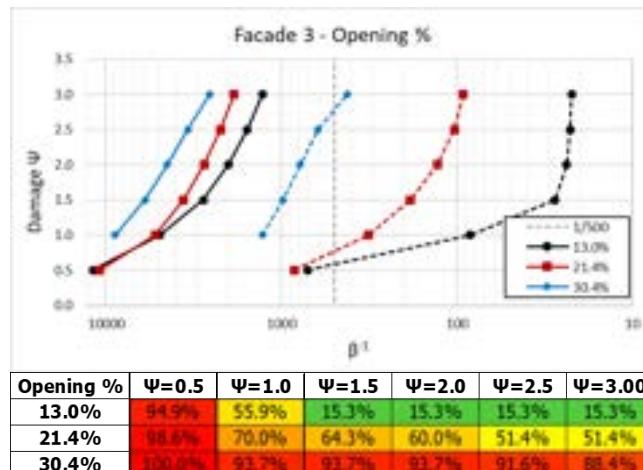
Figure 3.18. Angular distortion (β^{-1}) against damage and percentage of models that reach a specific damage level of Façade 3. Opening % variations. Dashed lines refers to applied β^{-1} .

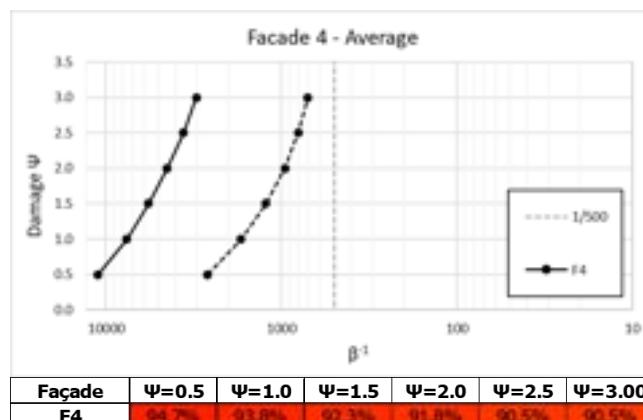
Figure 3.19. Angular distortion (β^{-1}) against damage and percentage of models that reach a specific damage level of Façade 4. Average values. Dashed lines refers to applied β^{-1} .

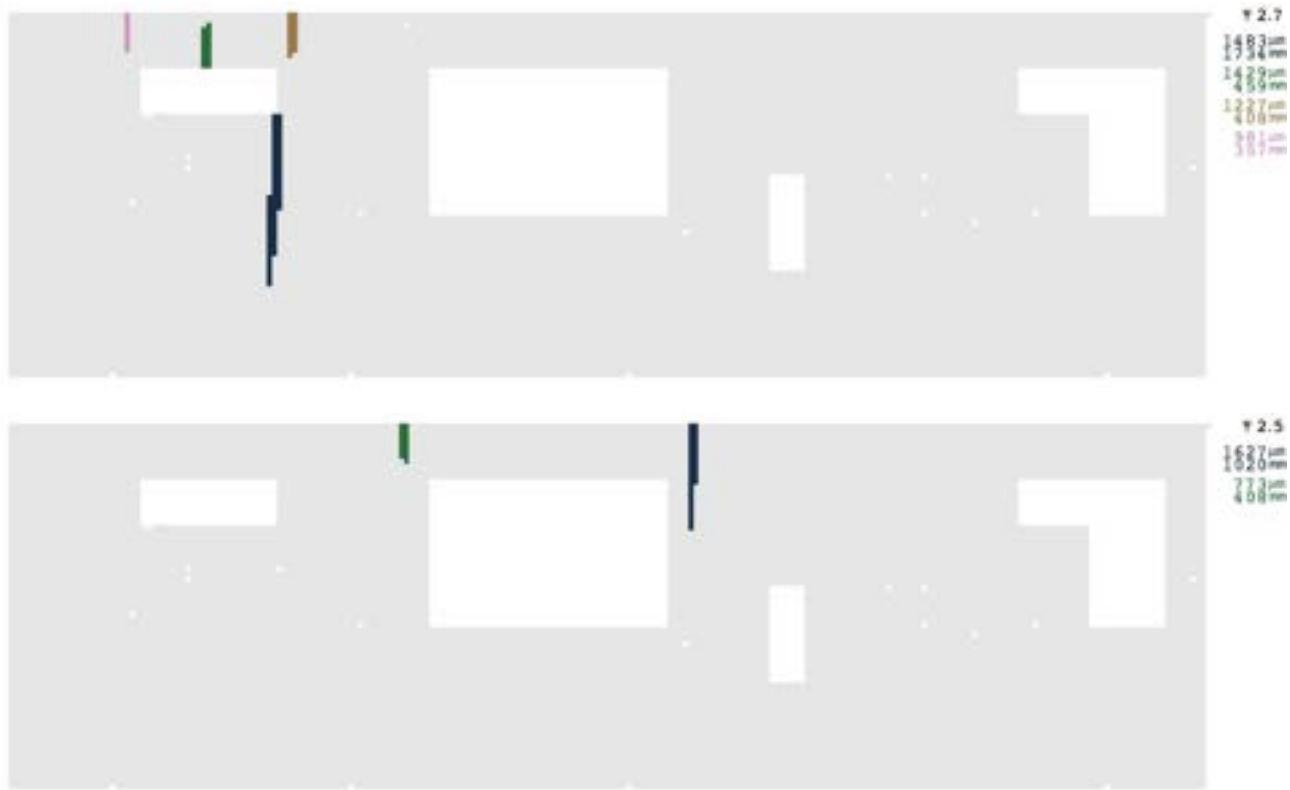
Figure 3.20. Crack pattern of Façade 4, geometry A, standard material, soil A, original interface at DS2. Asymmetric settlement, knick point L/3 (top) and symmetric settlement, knick point L/2 (bottom).

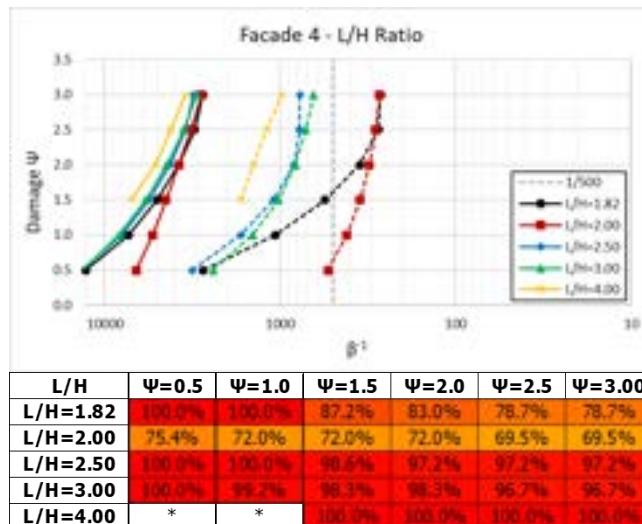
Figure 3.21. Angular distortion (^-1) against damage and percentage of models that reach a specific damage level of Façade 4. L/H ratio variations. Dashed lines refers to applied β^{-1} .Table 3.15. Measured (left) and applied (right) β^{-1} values of Façade 3. L/H ratio variations.

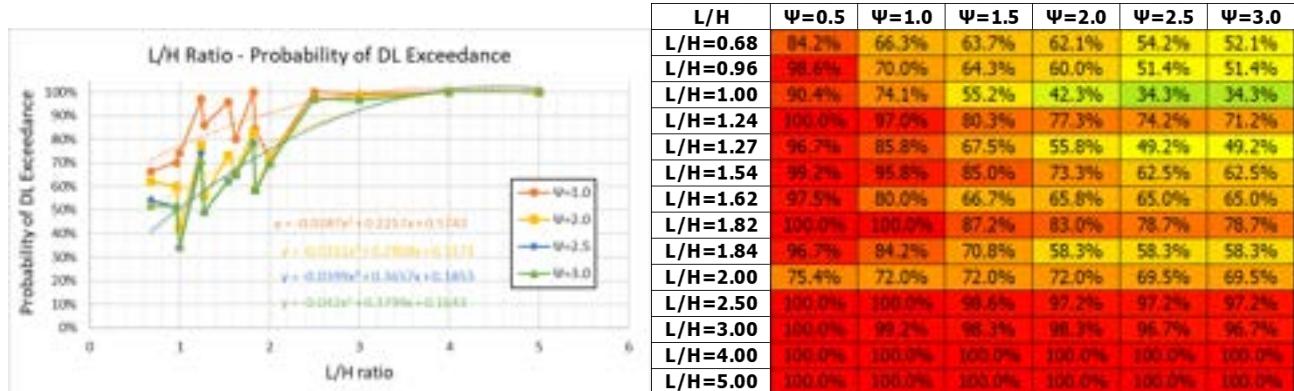
Figure 3.23. Amount of models subjected to a settlement of $\beta=1/10$ that reach a specific damage level. L/H ratio variation.

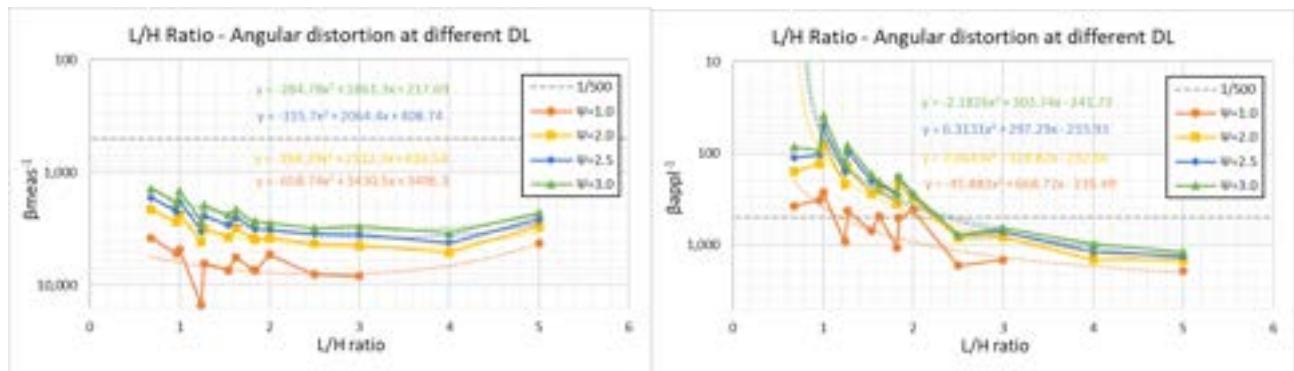
Figure 3.24. Measured (left) and applied (right) angular distortion (\wedge^{-1}) at different damage level. L/H ratio variation.

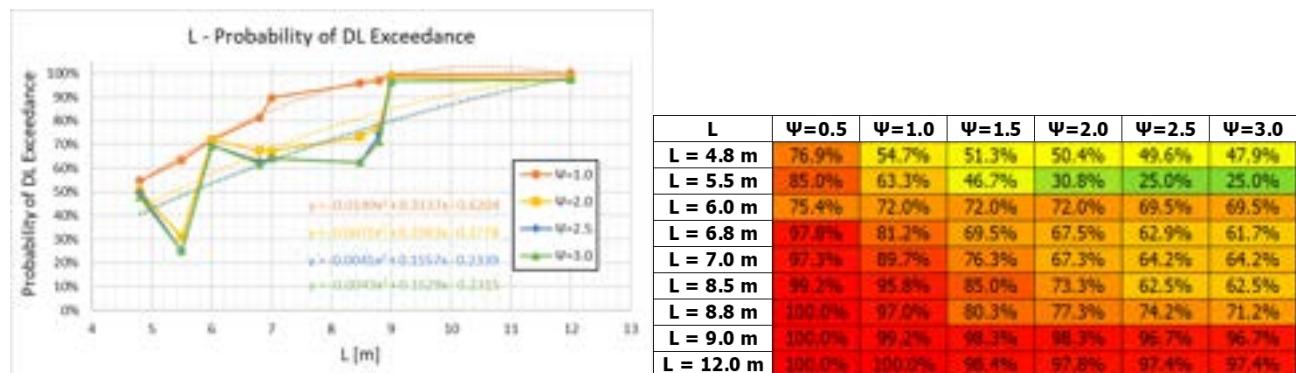
Figure 3.25. Amount of models subjected to a settlement of $\beta=1/10$ that reach a specific damage level. Length variation.

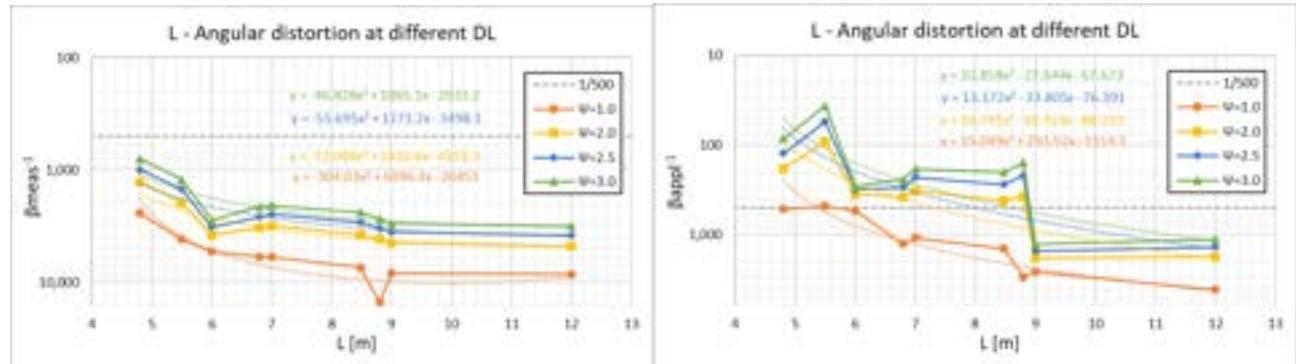
Figure 3.26. Measured (left) and applied (right) angular distortion (β^{-1}) at different damage level. Length variation.

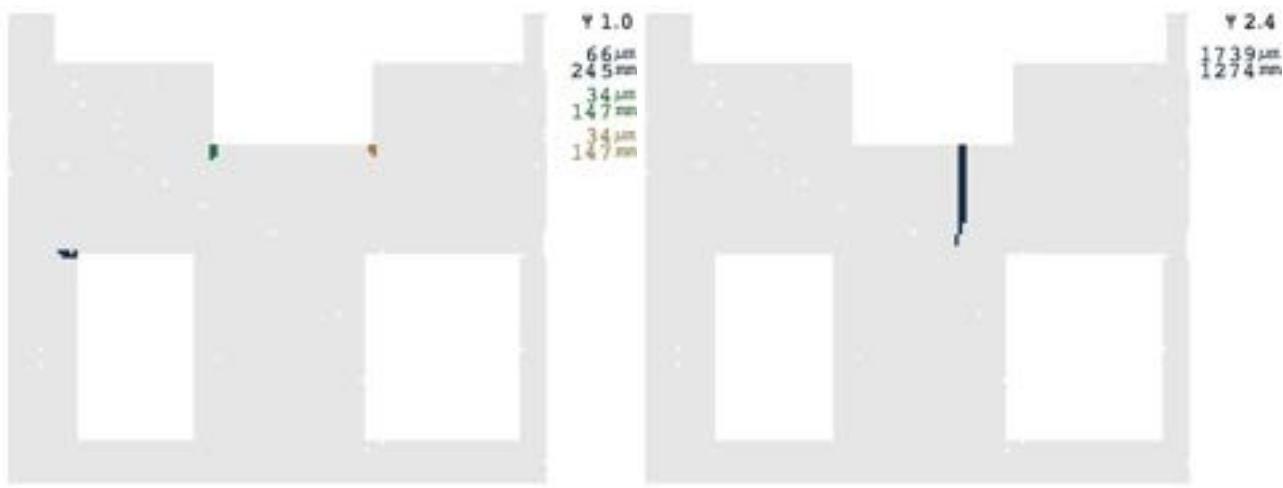
Figure 3.27. Crack pattern of Façade 5, geometry A, standard material, soil A, original interface and asymmetric settlement, knick point=L/3. Cracks at DS1 (left) and DS2 (right).
