**Instituut Mijnbouwschade
Groningen**

Betreft: Uw Woo-verzoek

Date 16/12/2020
 Internal reference TUD_MemoSubsidenceModelling_ConceptV1
 Authors Jan G. Rots, Paul Korswagen Eguren, Michele Longo
 E-mail J.G.Rots@tudelft.nl, P.A.KorswagenEguren@tudelft.nl
 Document name Computational modelling checks of masonry building
 damage due to deep subsidence
 Document type Memorandum

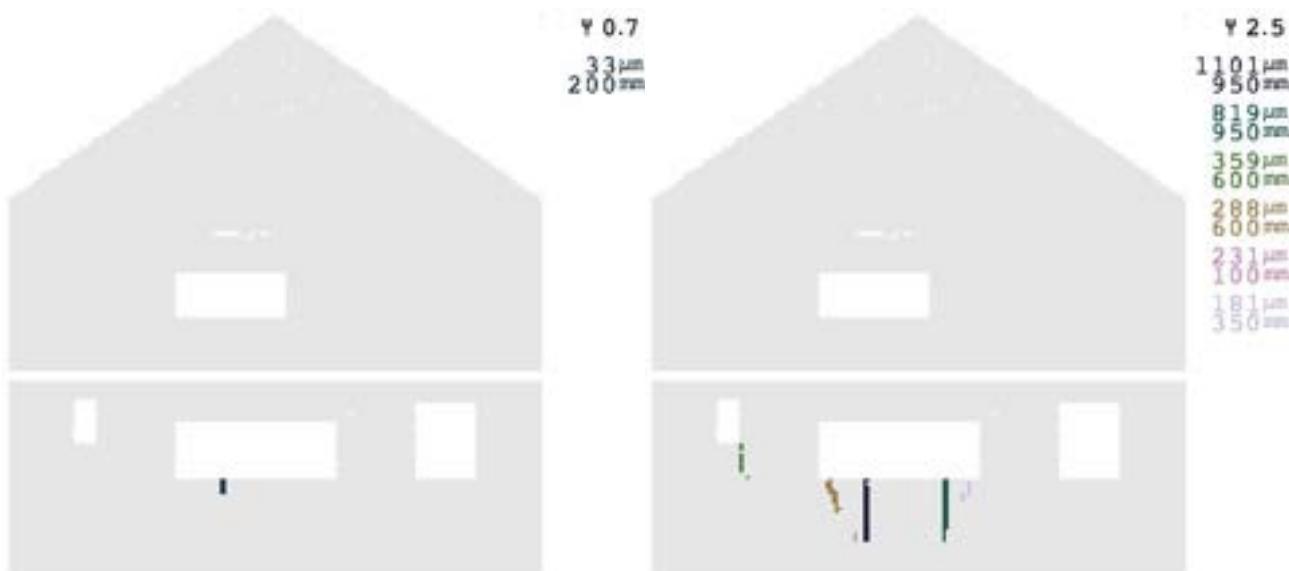
Figure 3.28. Crack pattern of Façade 6, geometry A, standard material, soil A, original interface and asymmetric settlement, knick point=L/3. Cracks at DS1 (left) and DS2 (right).

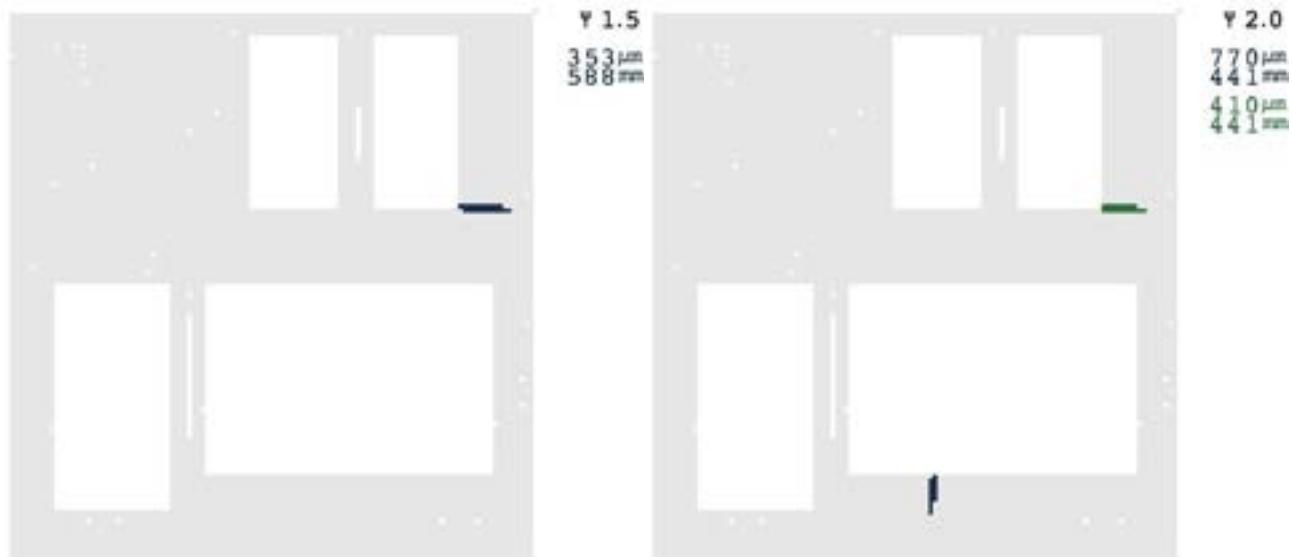
Figure 3.29. Crack pattern of Façade 7, geometry A, standard material, soil A, original interface and asymmetric settlement, knick point=L/3. Cracks after vertical loading (left) and applied beta at $\Psi=2$ (right).

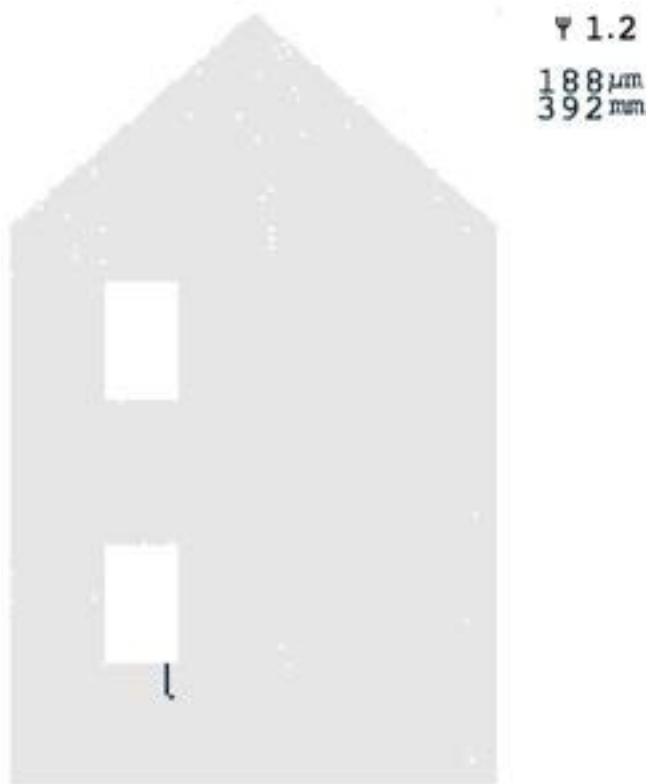
Figure 3.30. Crack pattern of Façade 8-B, geometry A, standard material, soil A, original interface and asymmetric settlement, knick point=L/3. Cracks at $\Psi=1.2$.

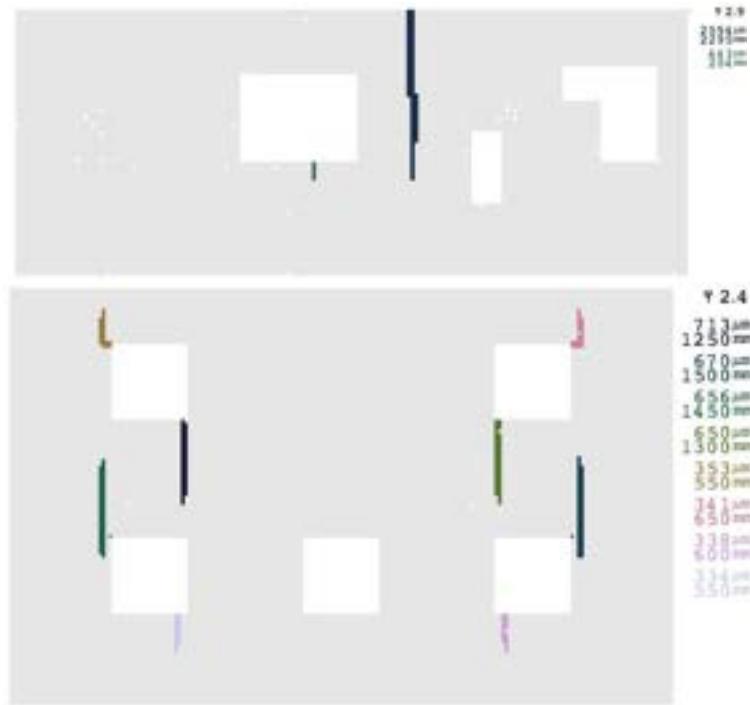
Figure 3.31. Crack pattern of Façade 9, geometry A (top) and B (bottom), weak material, soil A, original interface and asymmetric settlement, knick point=L/3. Cracks at $\Psi \geq 2$.

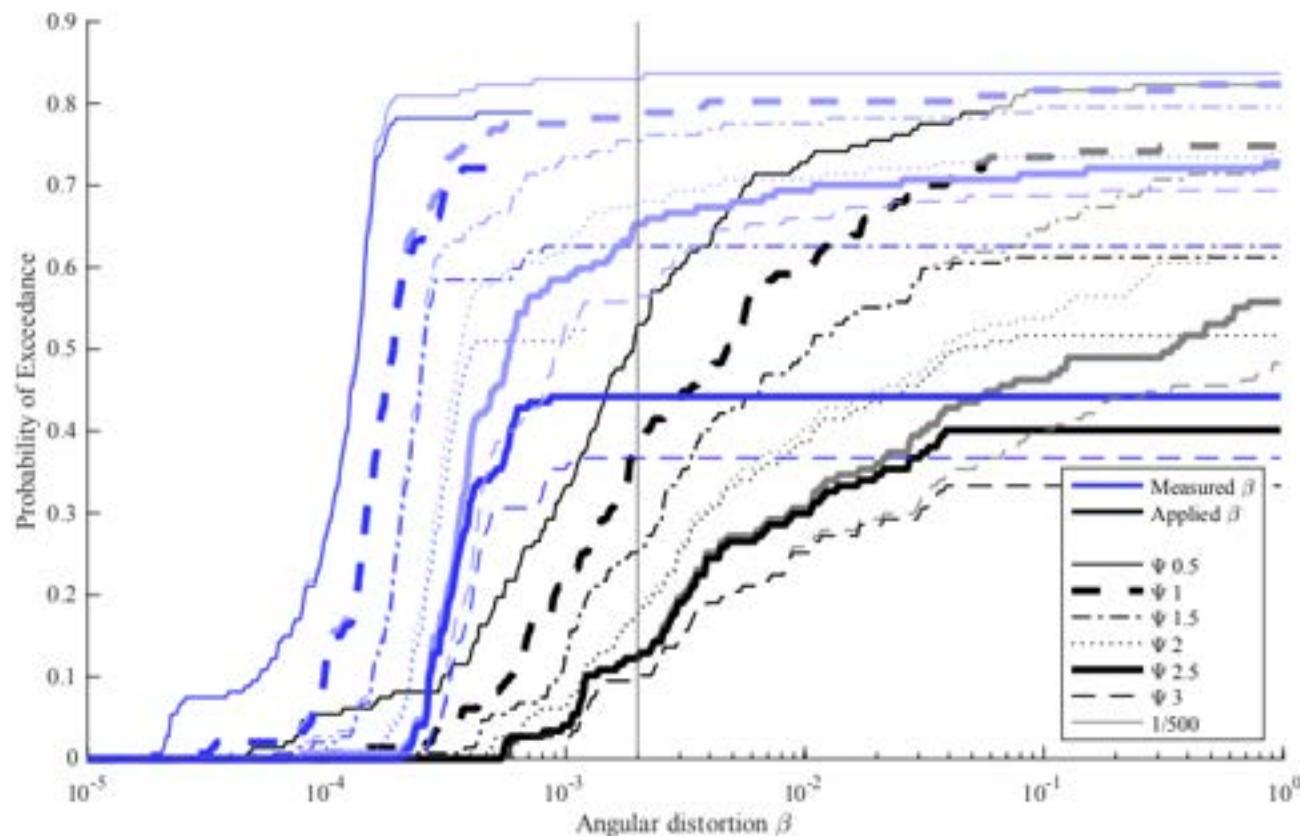
Figure 4.1. Curve for the exceedance count, ‘deterministic fragility curves’, of various damage thresholds for both measured and applied distortion. The lines with extrapolations continue in a dim colour, while the capped curves show the percentage of models that actually reached the indicated damage values (Ψ).

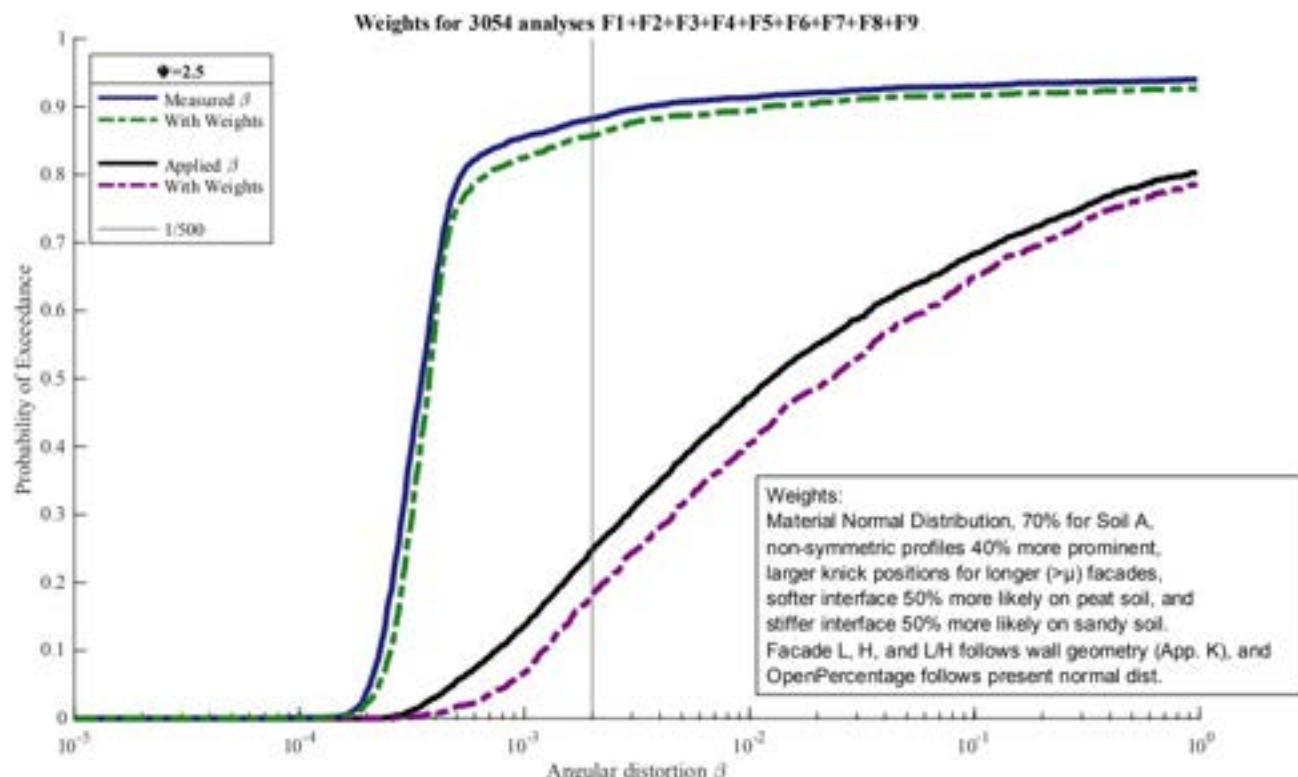
Figure 4.2. Exceedance curve with and without weights for both the applied and the measured distortion.

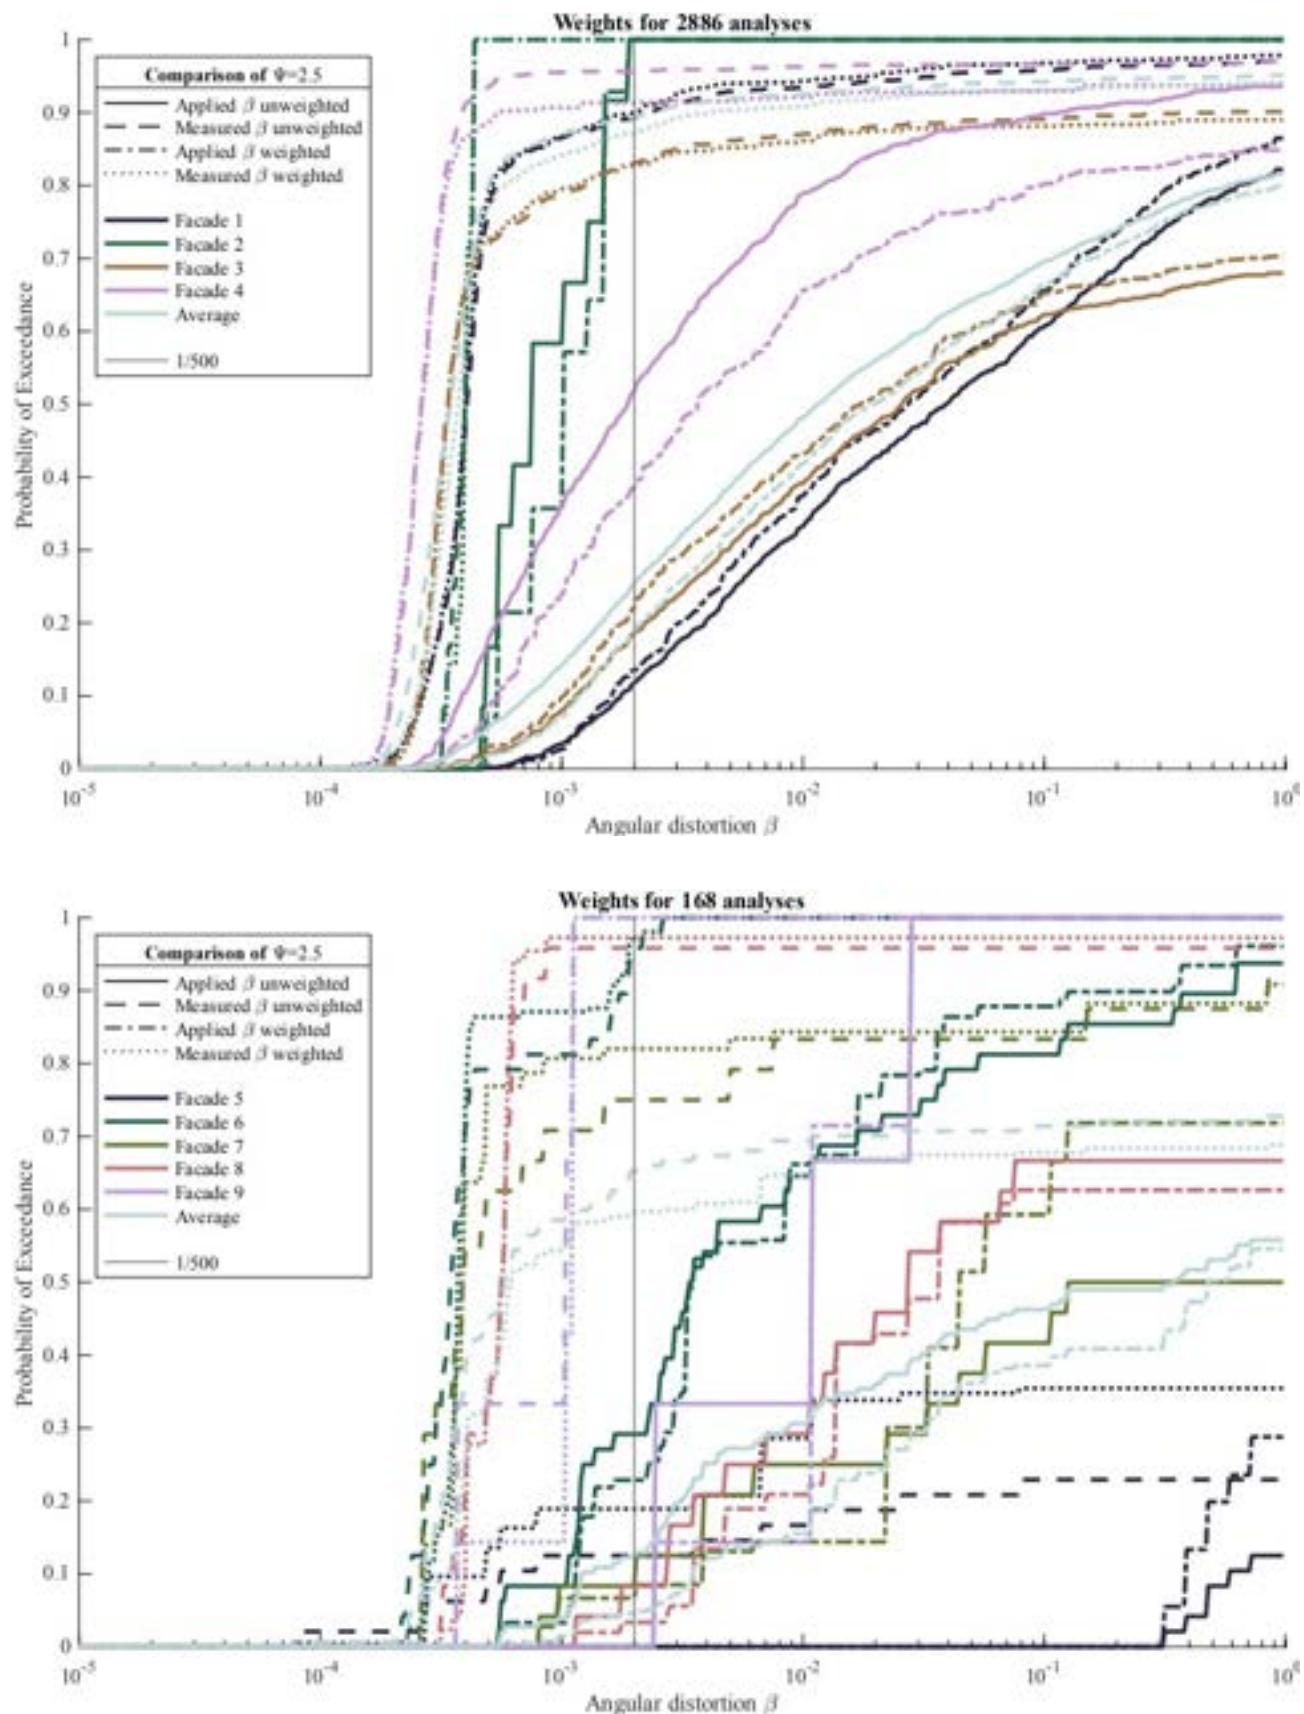
Figure 4.3. Weighted exceedance curves segregated per façade; top, for fired-clay brick on UR foundations; bottom, for Calcium-silicate facades on RC foundations. The longer façade 4 is most vulnerable and also most affected by the weighting scheme.

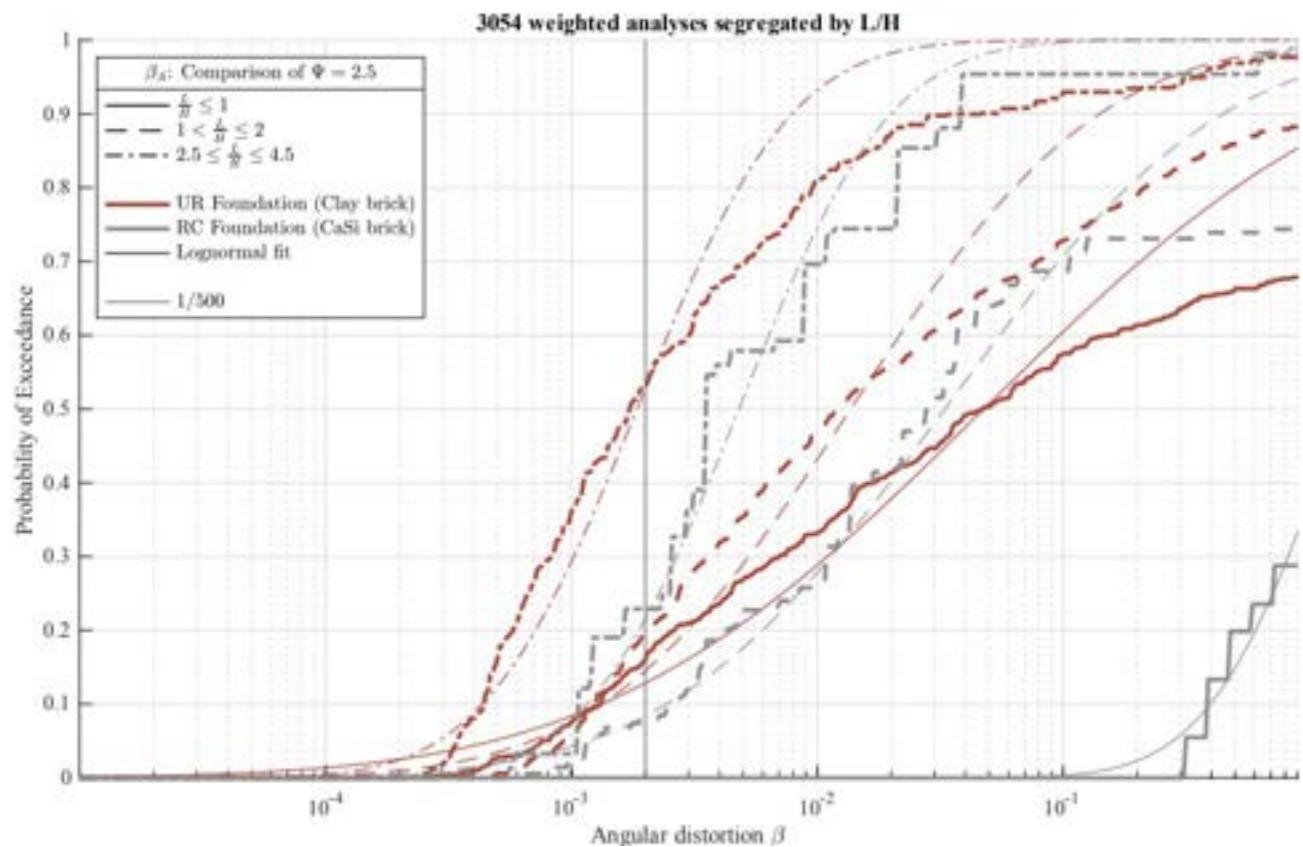
Figure 4.4. Exceedance curves for applied angular distortion against damage probability separated by length/height ratio and foundation type with the corresponding lognormal fit which more adequately represents low (and high) values of probability.

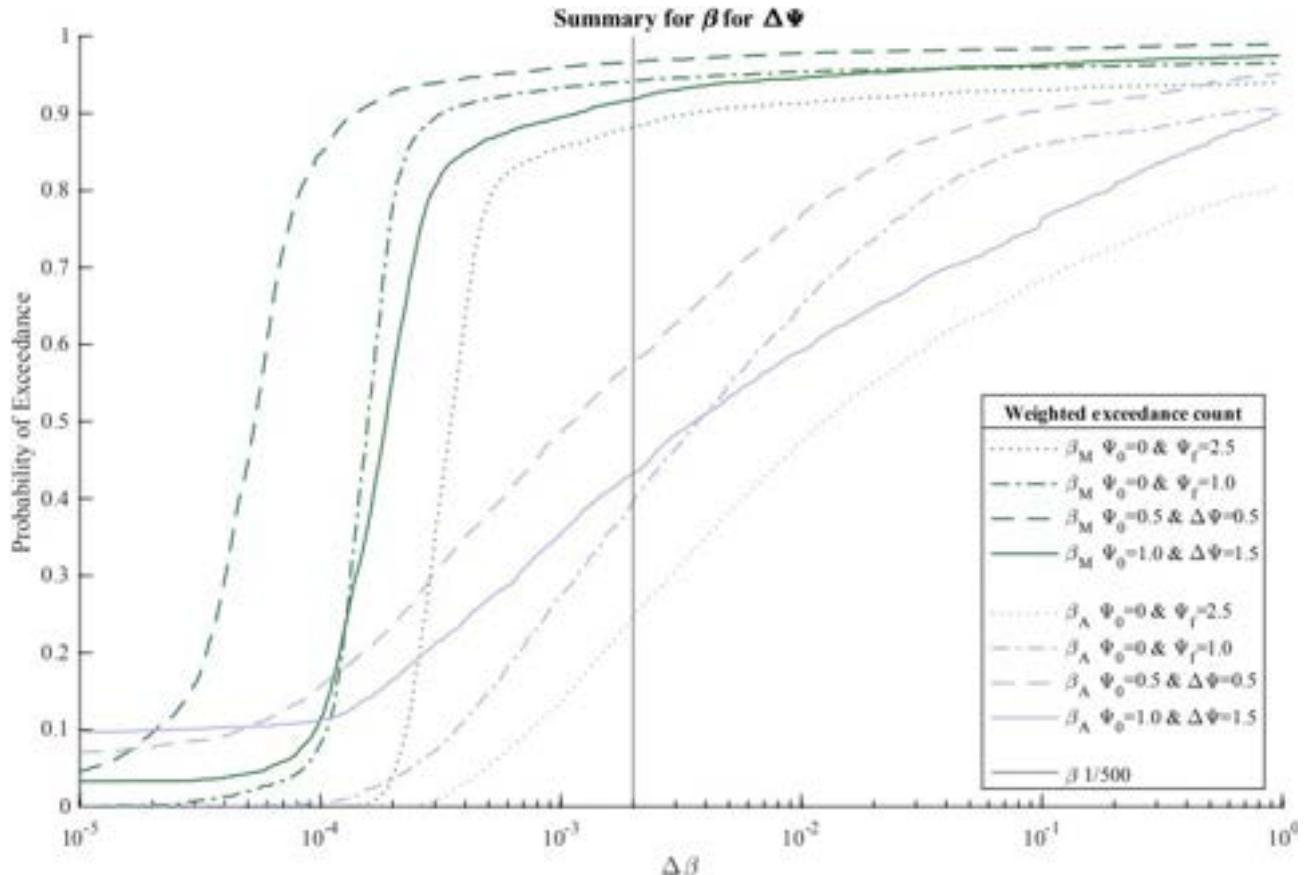
Figure 5.1. Delta Psi and delta beta.

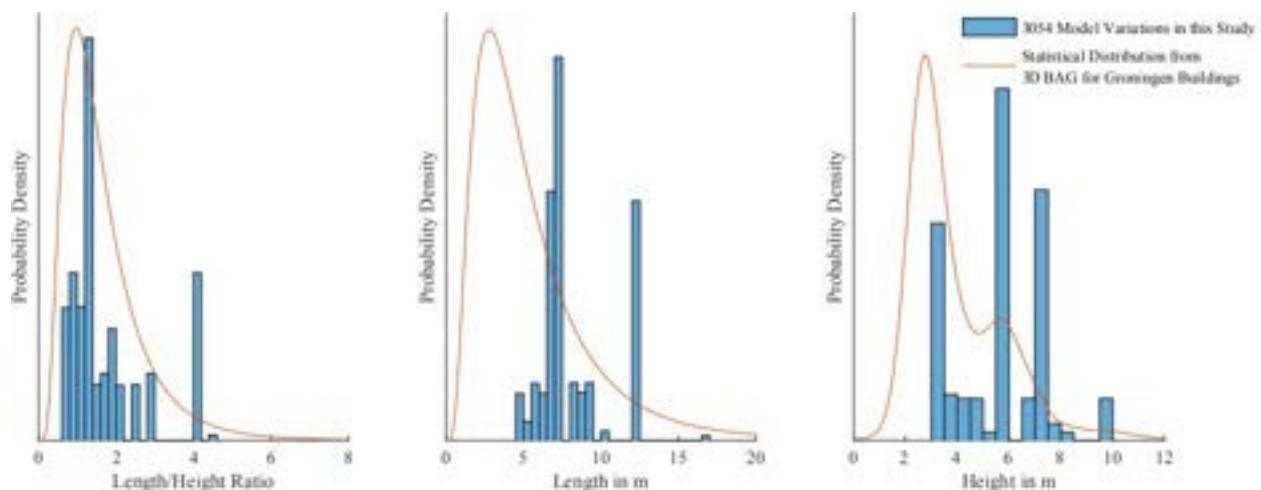
Figure 5.2. Comparison of the length, height, and length/height ratios employed in this study and the statistical distribution observed from an analysis of real buildings' wall geometries.

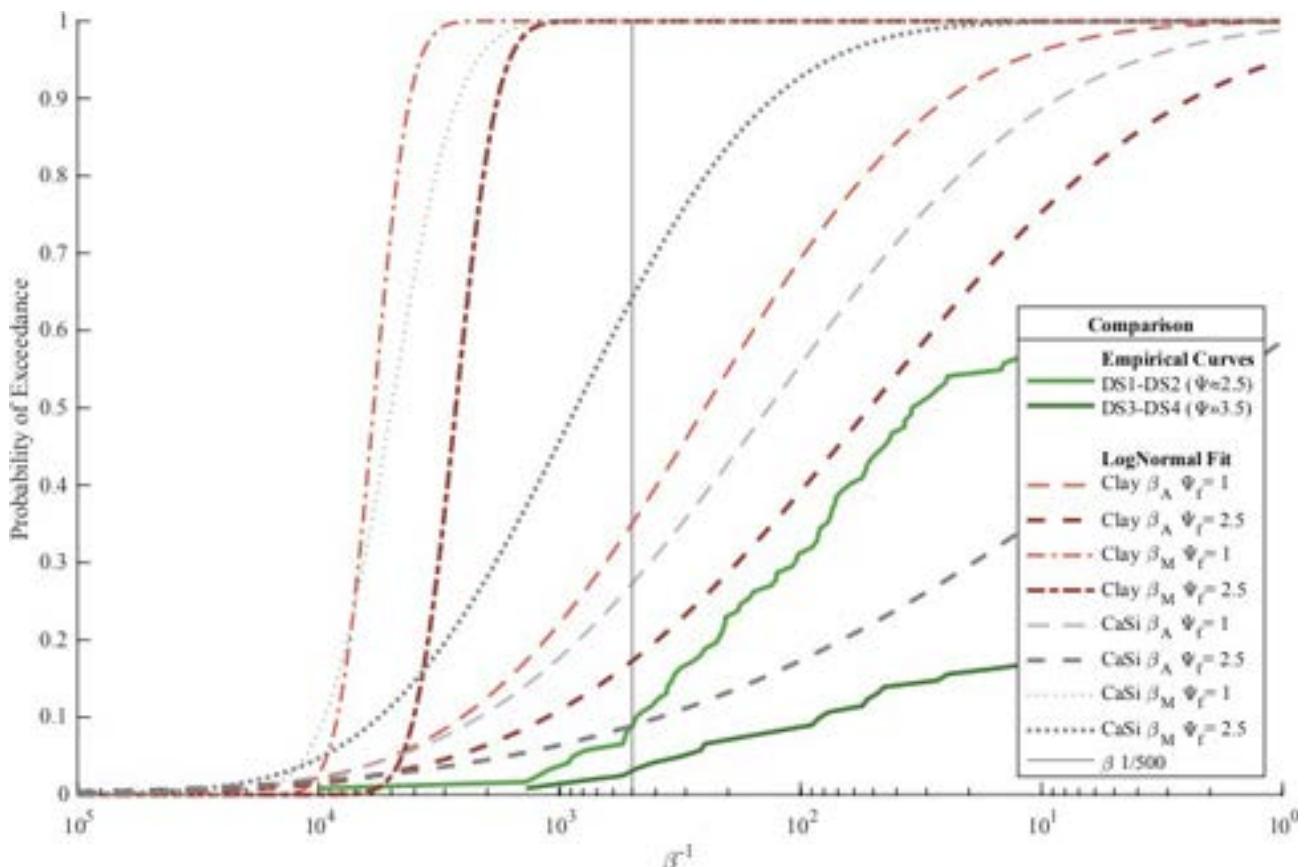
Figure 5.3. Comparison of fragility curves against empirical curves developed from field data.

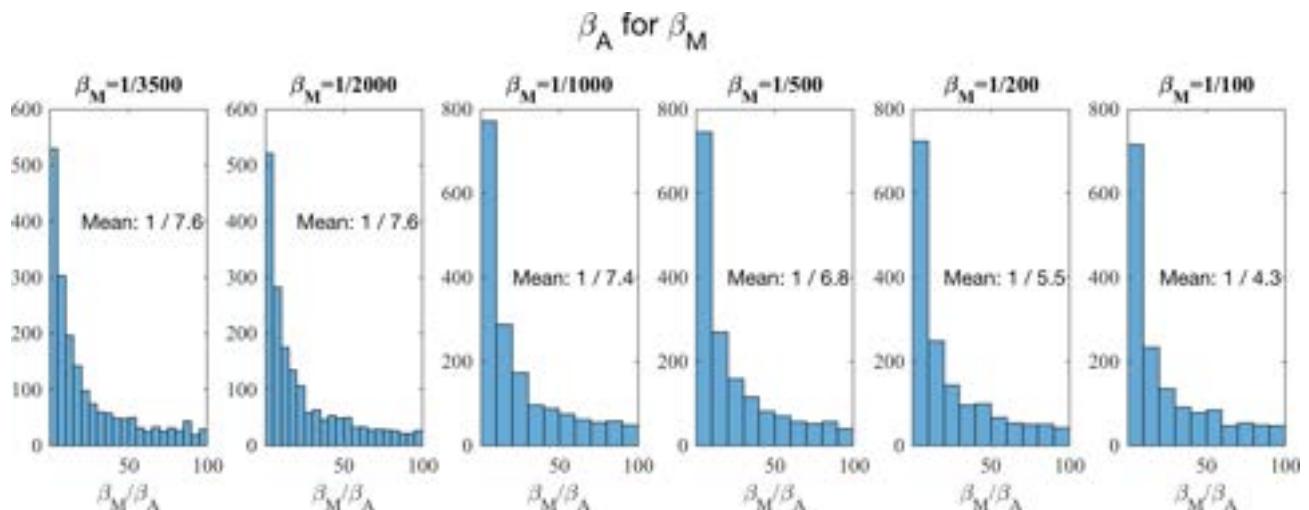
Figure 5.4. Ratios between the measured wall distortion and the applied soil distortion for buildings on unreinforced foundations. Buildings that don't become damaged, also don't follow the applied soil deformation and thus present high ratios.

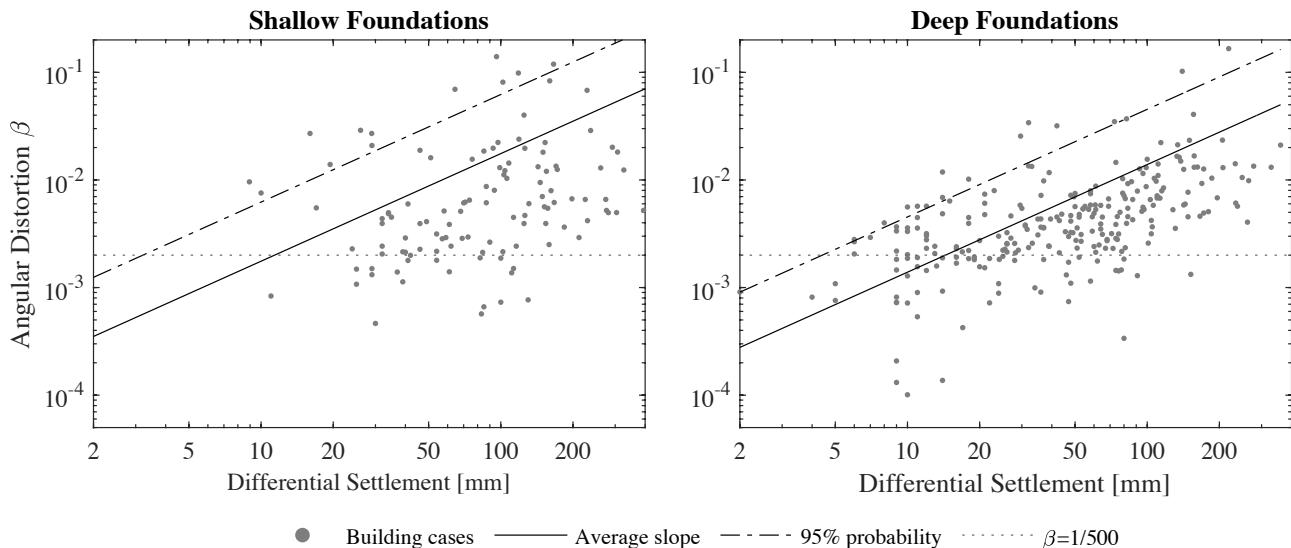
Figure 2. Relationship between the differential settlement and the angular distortion measured on the masonry façades from a database of 396 buildings [3].

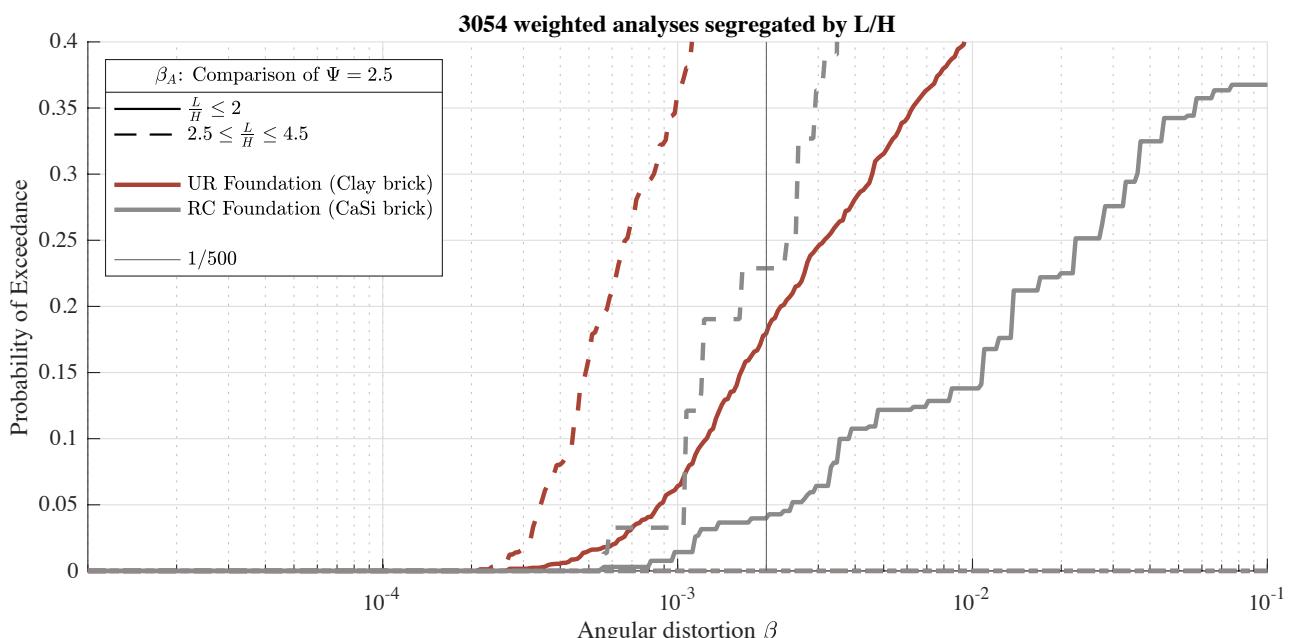
Figure 3. Relationship between the probability of reaching or exceeding crack-based damage with cracks in the order of 2 mm in width ($\Psi=2.5$ marks the transition from DS1 to DS2) and the applied angular soil distortion underneath the buildings' foundations.

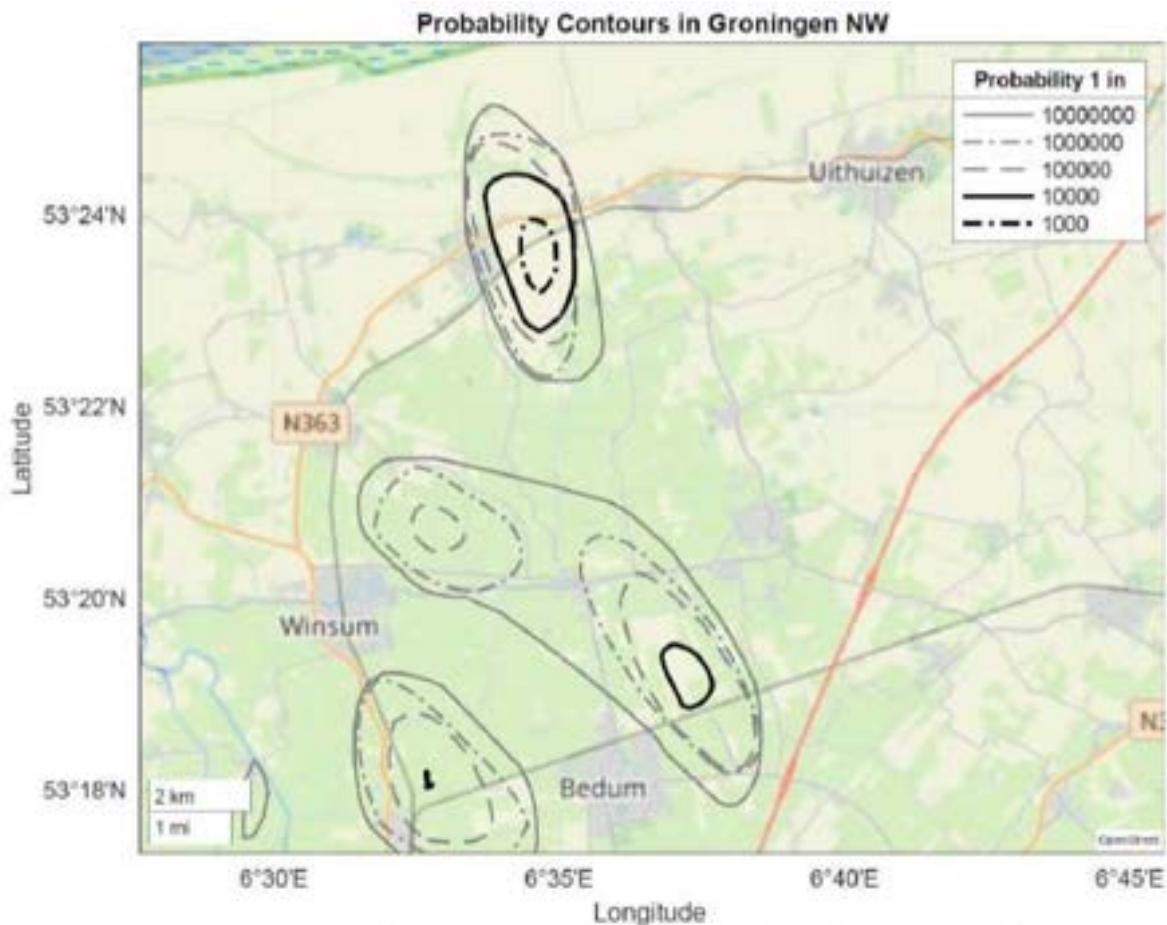
Figure J.13. Probability contours in the NW of Groningen for light damage ($\Psi=1$) of buildings with unreinforced masonry structures.
